## **Capital Improvement Project – Westside Plant, College Ave., Deerfield Pumpstation**

## ***Capital Improvement Project – Westside Plant – Headworks Building***

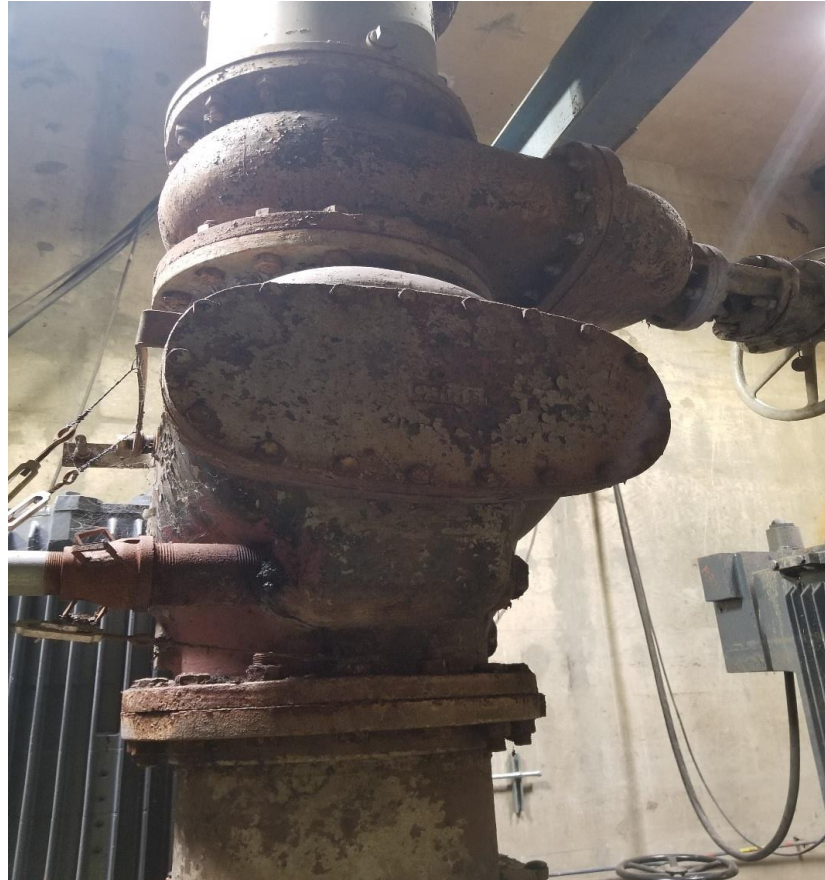
P-20 has a 16-inch diameter gate and check valve. Both the gate and check valves are not properly working.

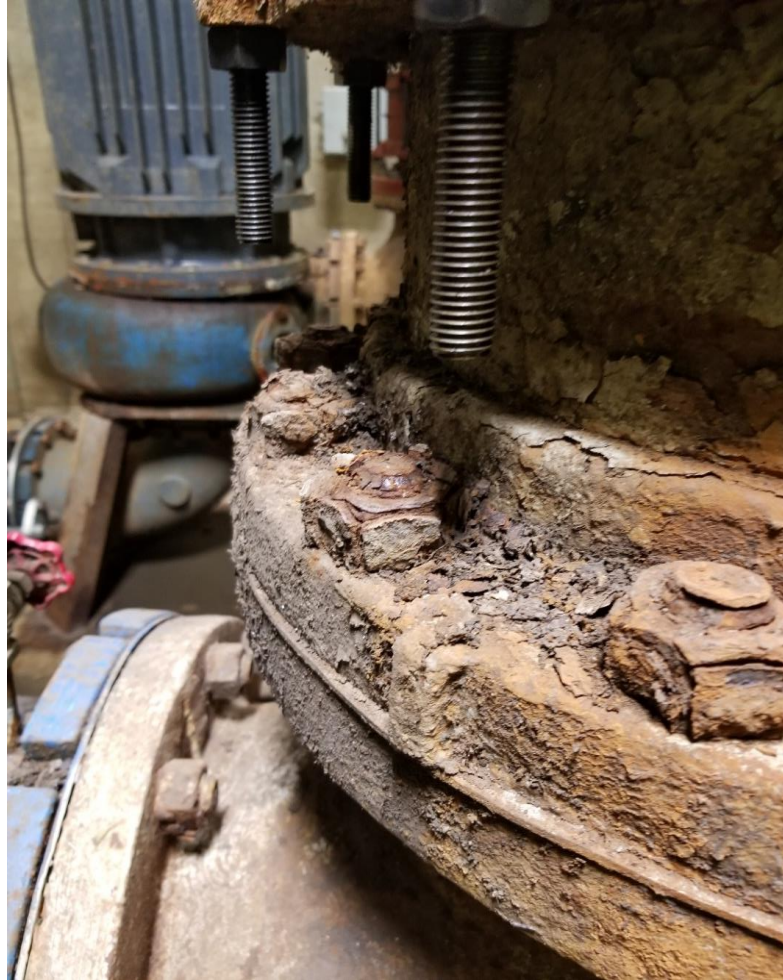
P-10 & 20 has a 16-inch diameter discharge piping that needs replaced due to age and corrosion.

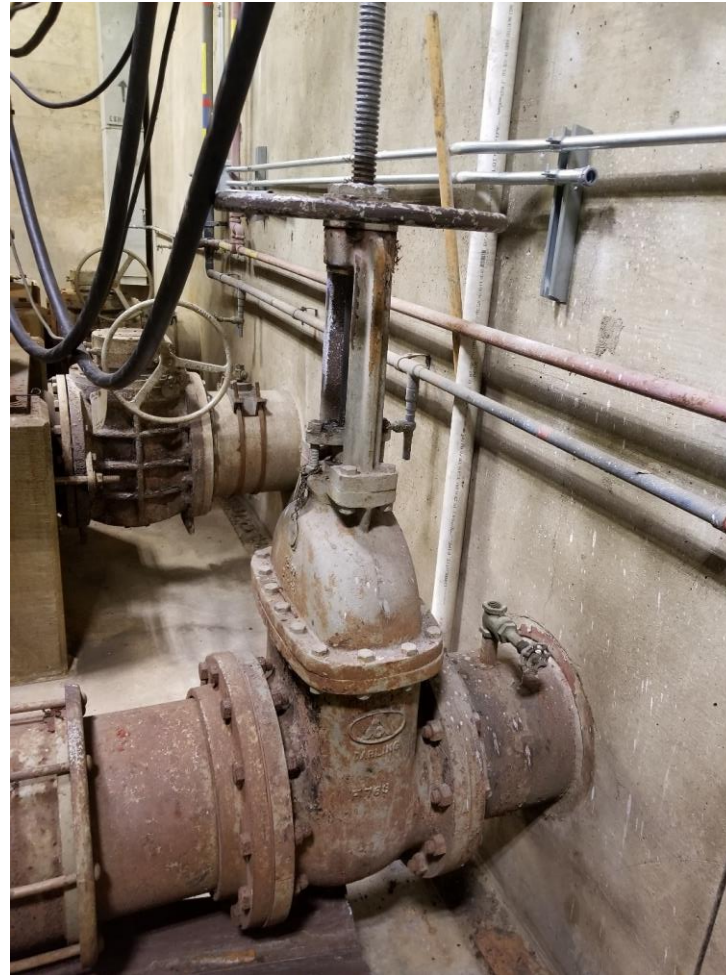
P-20 has a 12-inch diameter inlet valve that does not work at all.

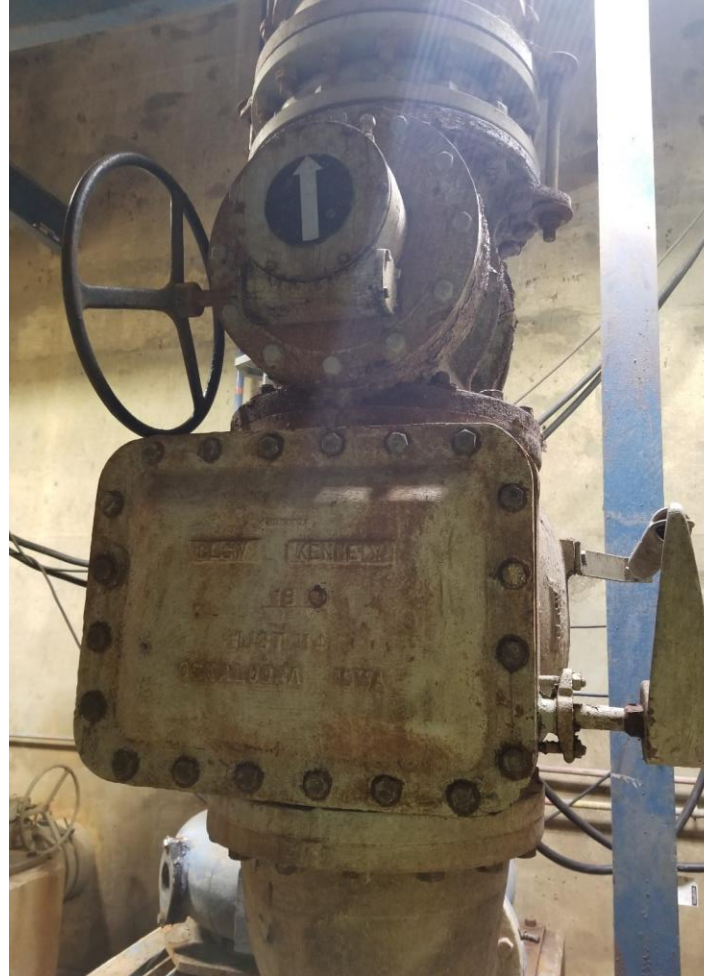
P-30 has an 18-inch diameter plug and check valve that does not seal shut.

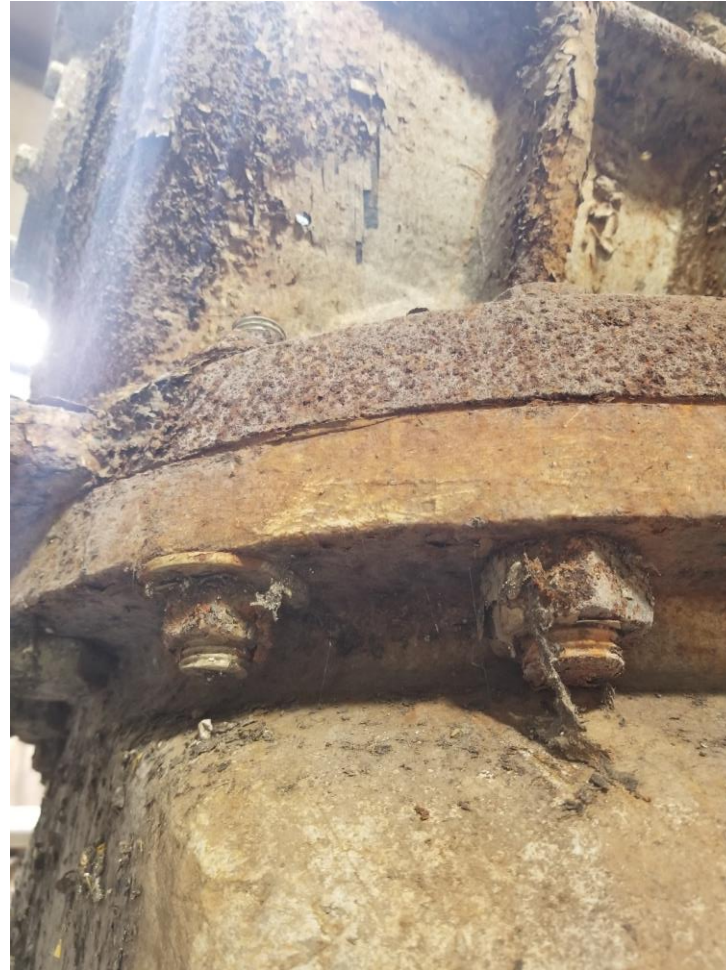
P-30 has an 18-inch diameter discharge piping that needs replaced due to age and corrosion.

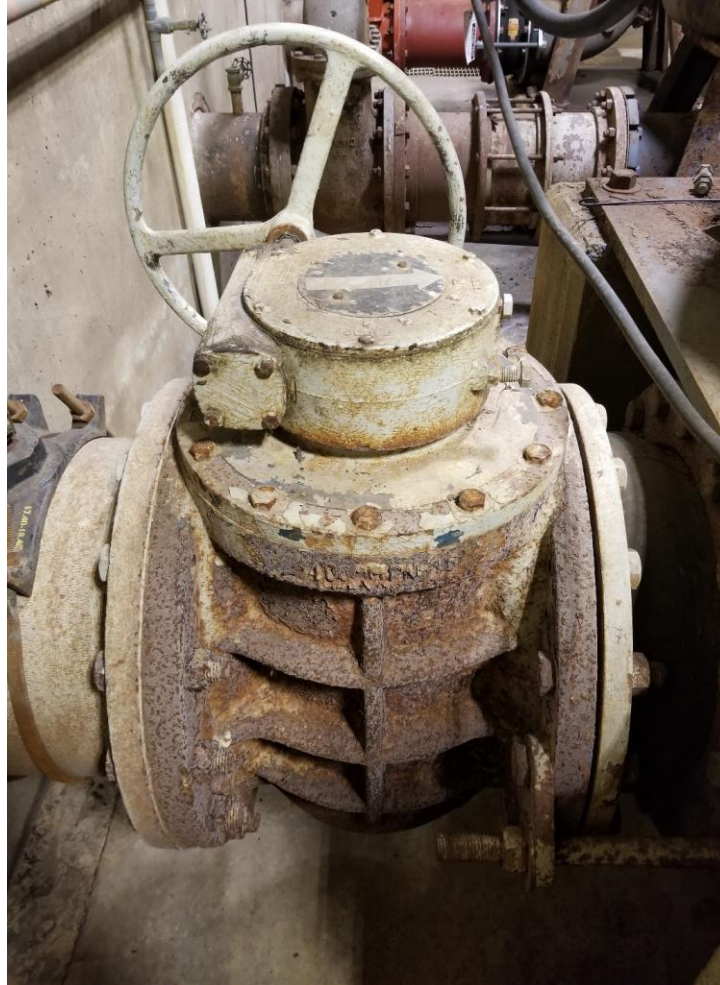
P-30 has an 16-inch diameter inlet plug valve that does not seal shut.

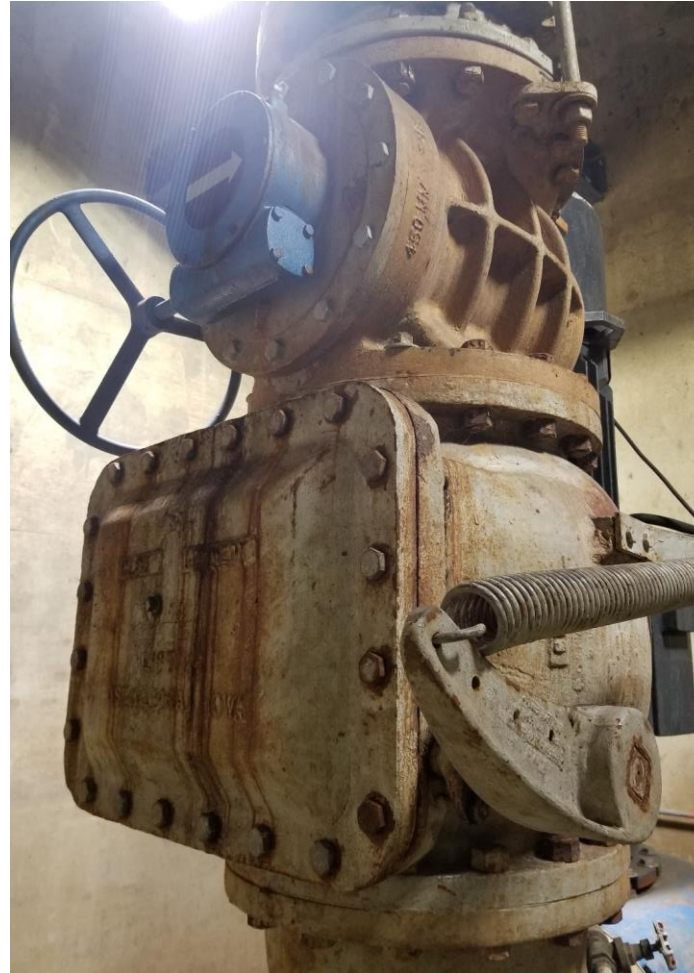
P-40 has an 18-inch diameter plug and check valve that does not seal shut.

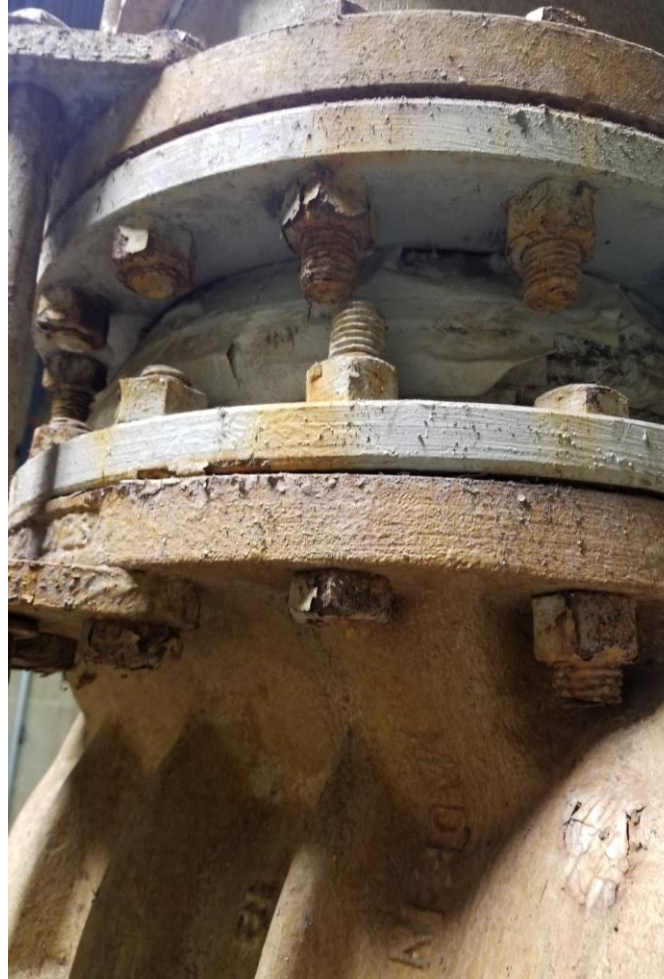
P-40 has an 18-inch diameter discharge piping that needs replaced due to age and corrosion.

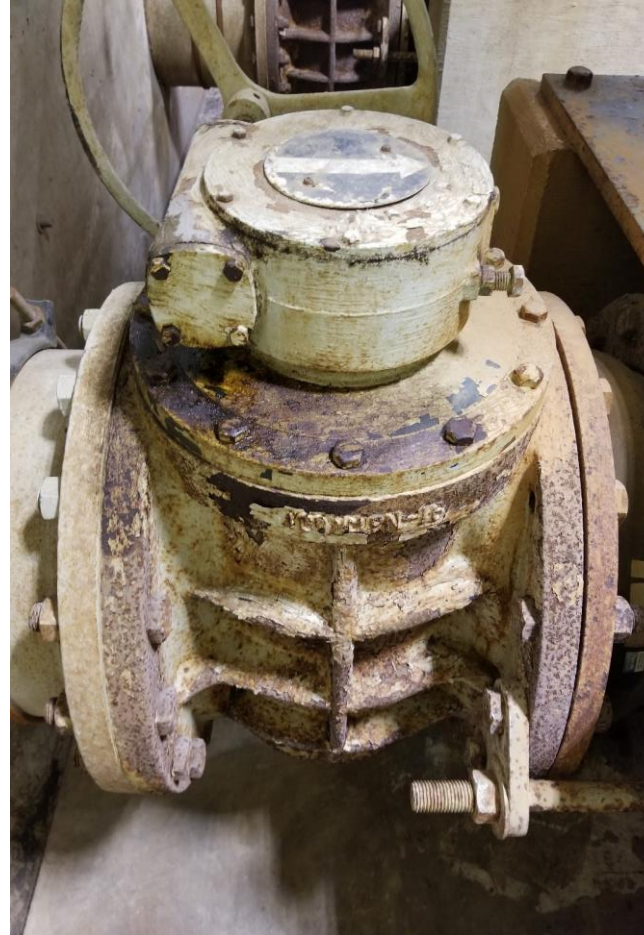
P-40 has an 16-inch diameter inlet plug valve that does not seal shut.

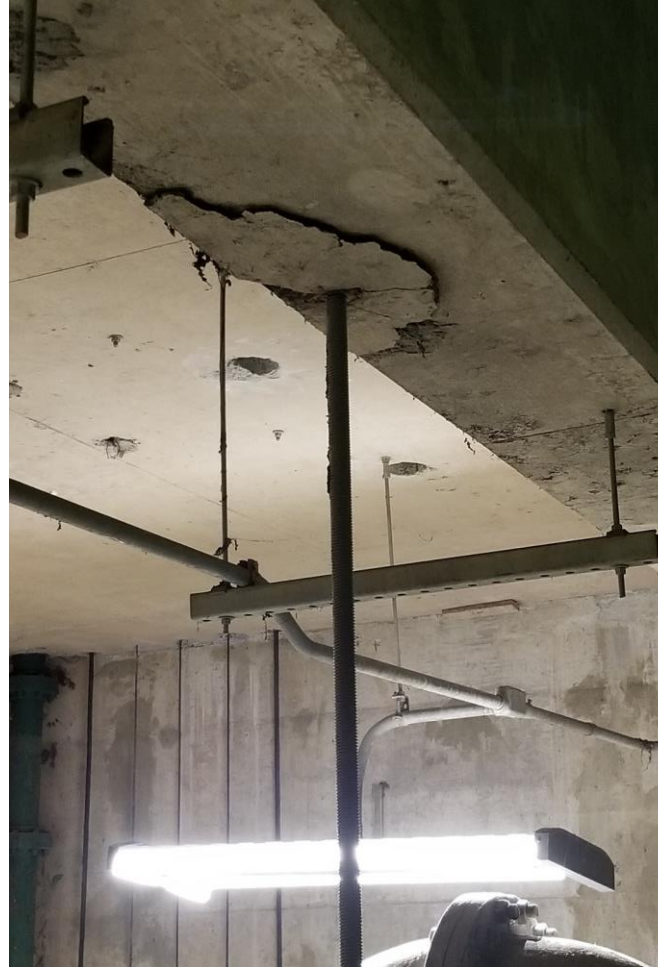
Main Line support brackets need to be replaced before failure.

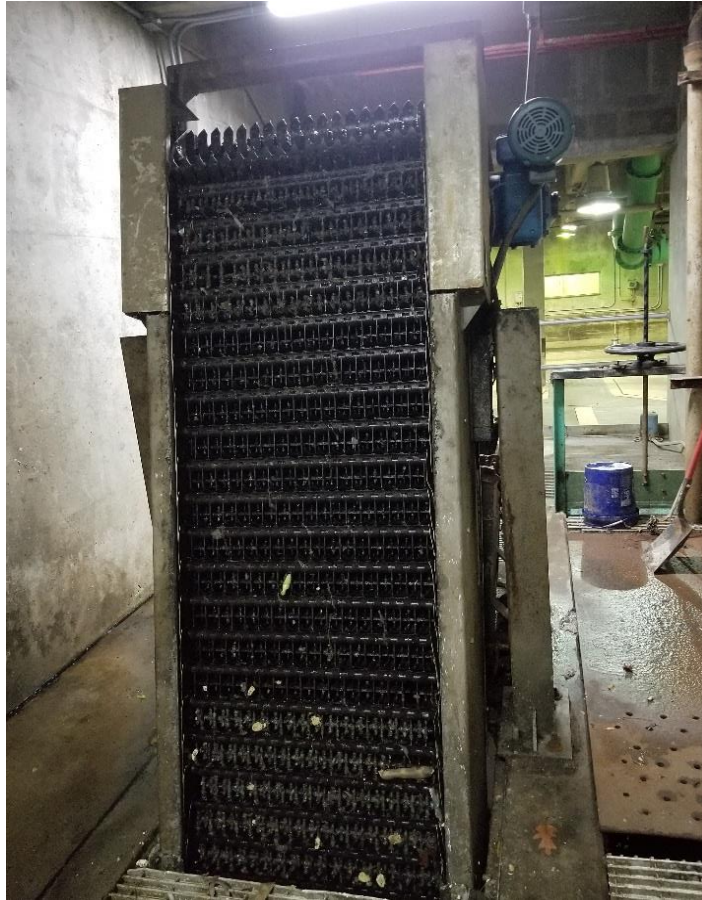
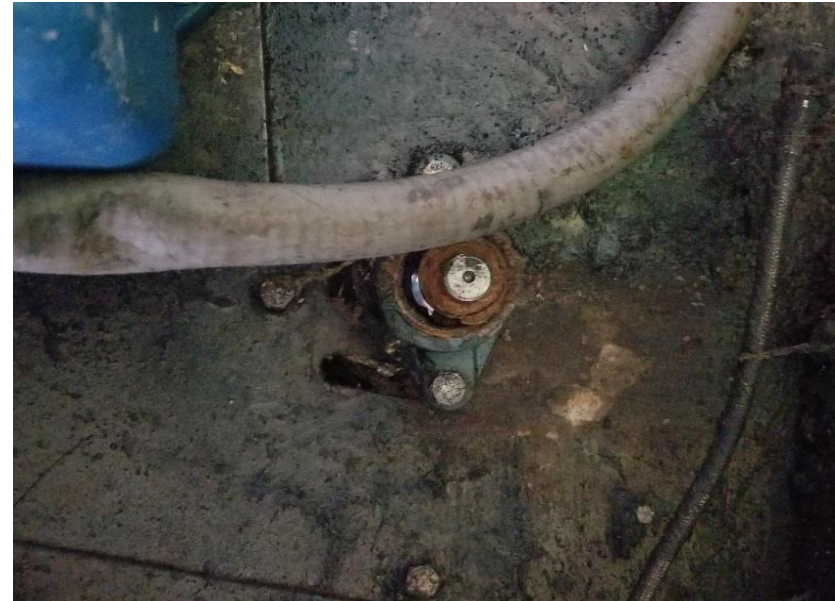
Main Pump Station Barscreen is over 25 years old

This screen collects all trash before entering main pump. It is beyond repair and is allowing trash to damage pumps causing costly repairs.

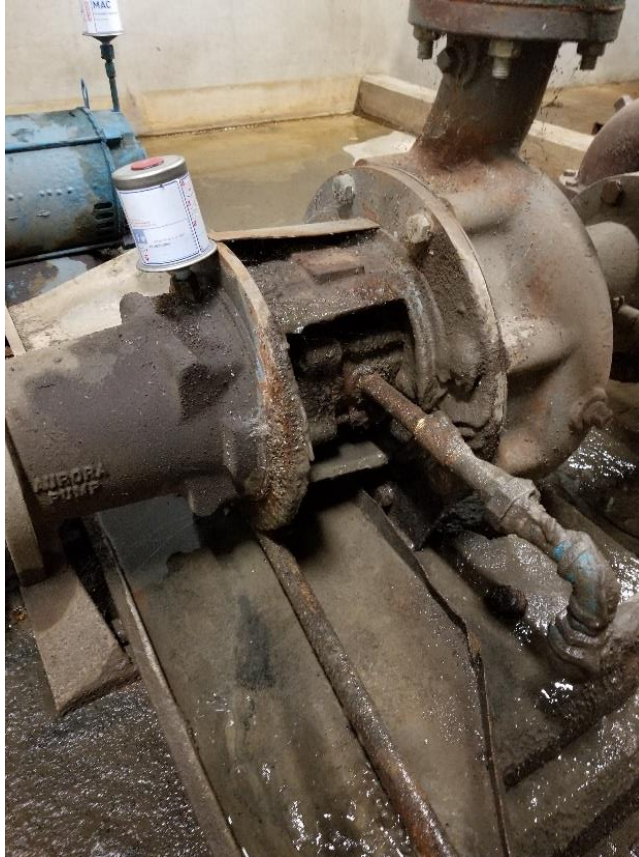
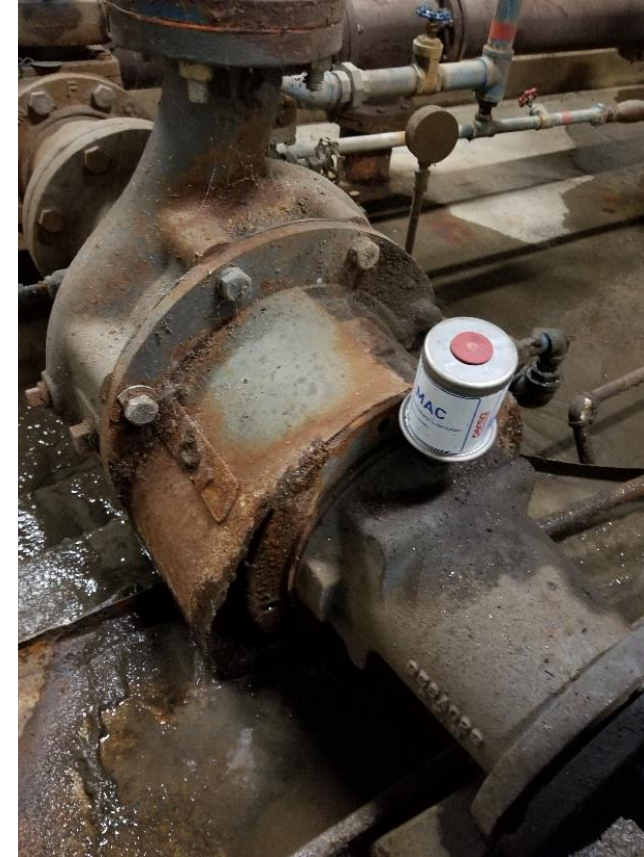
Grit Pumps are in need of replacement due to wear and age. The pump's seals are leaking under constant repair.

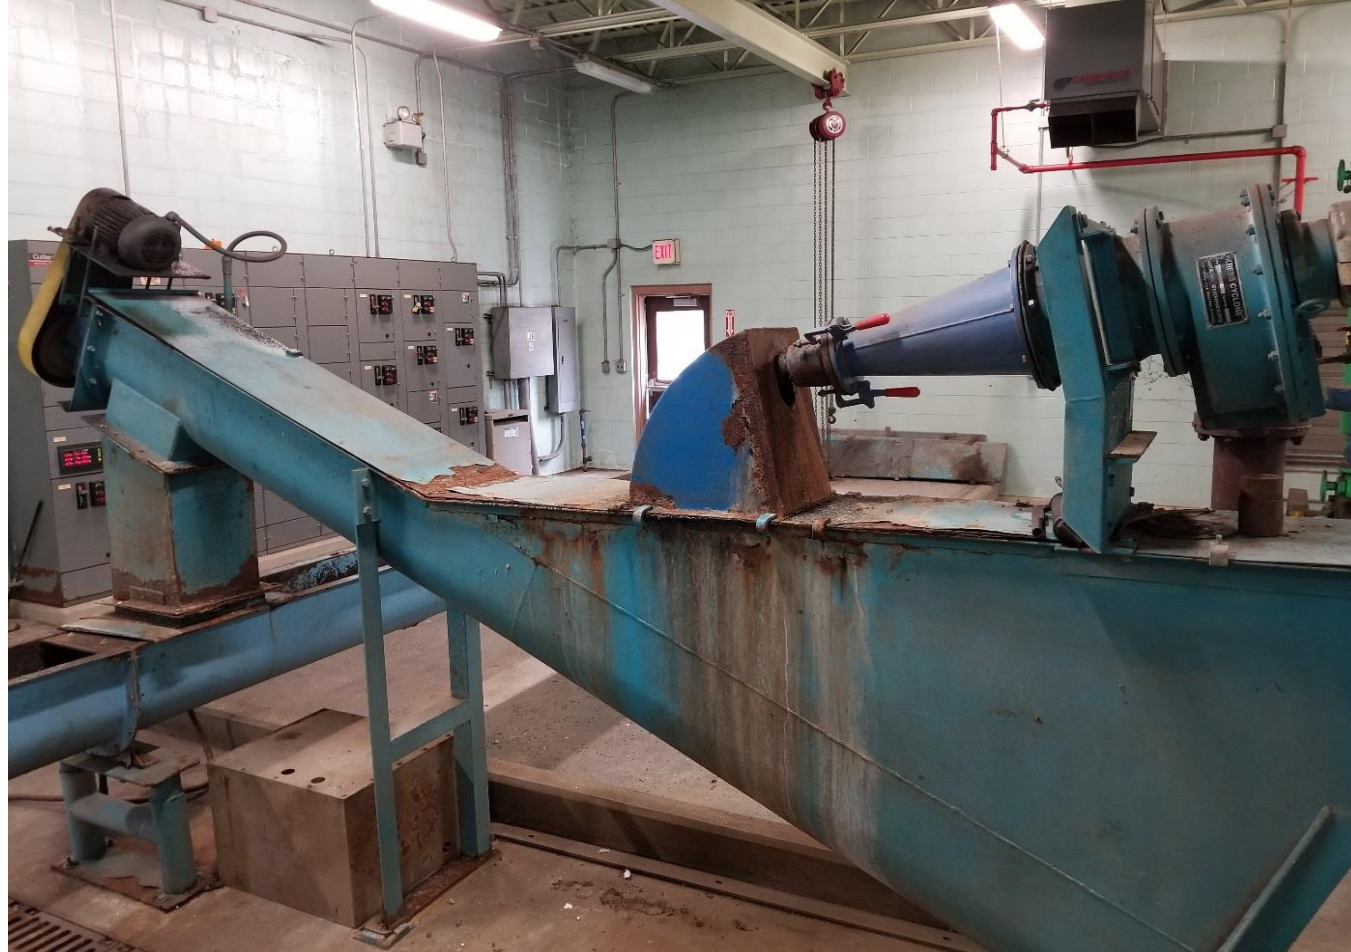
Grit Screw Conveyor is showing signs of corrosion and has been patched numerous times.

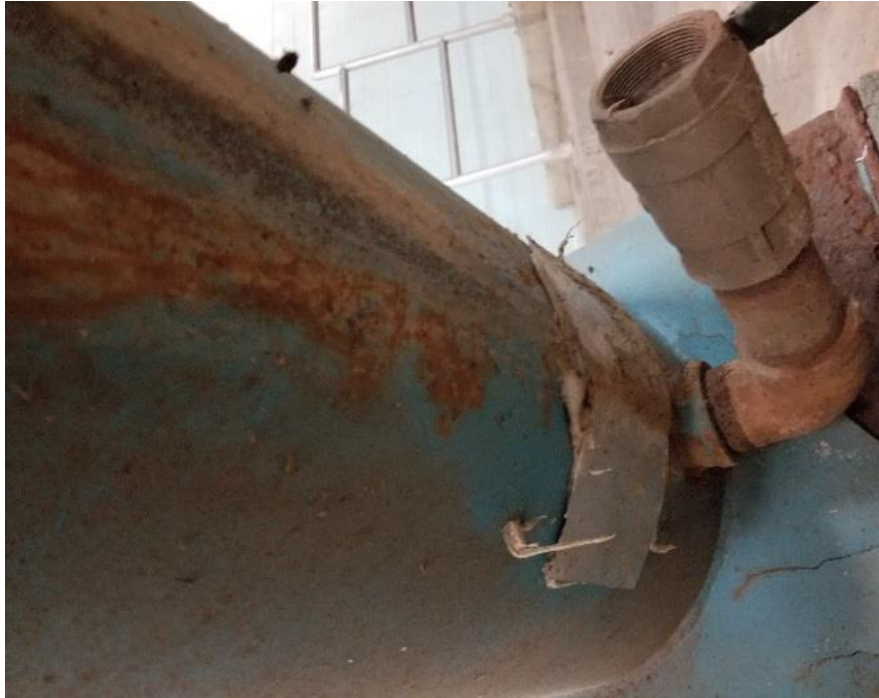
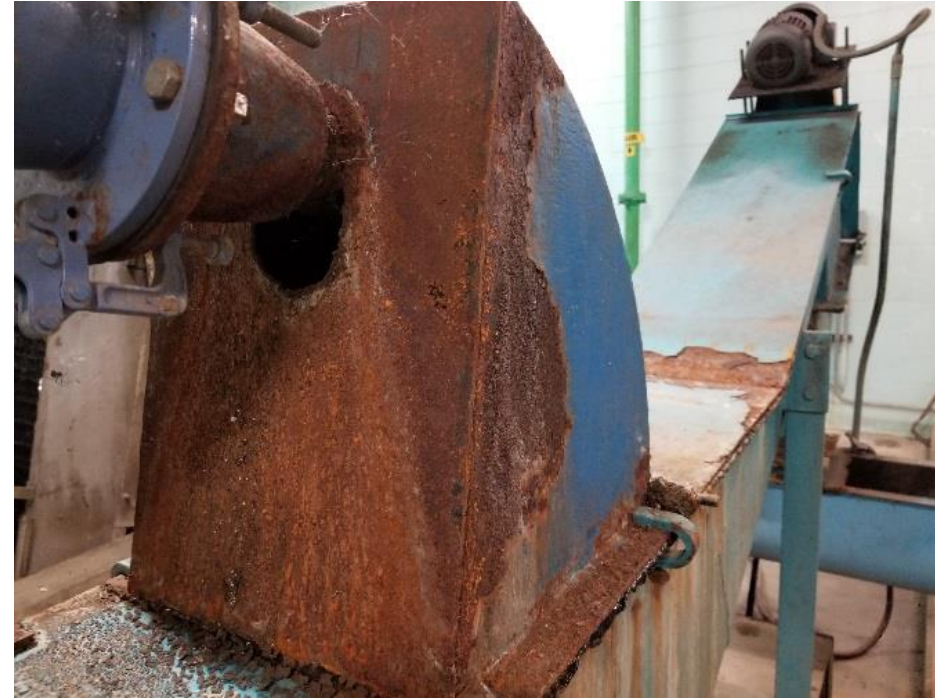
Grit Wash Cyclone Nozzle can no longer be repaired and needs to be replaced.

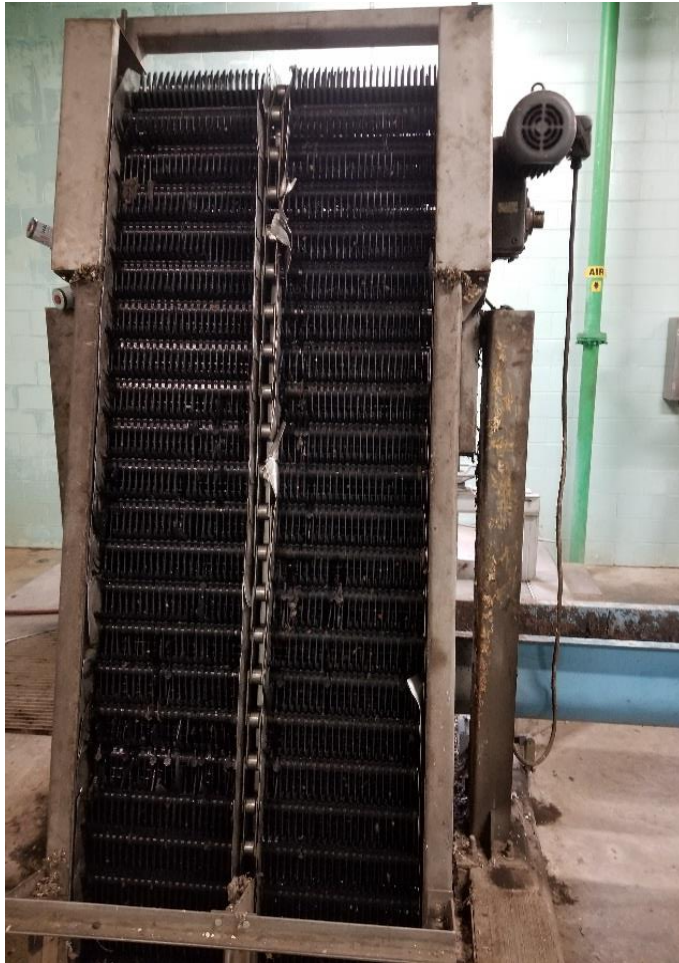
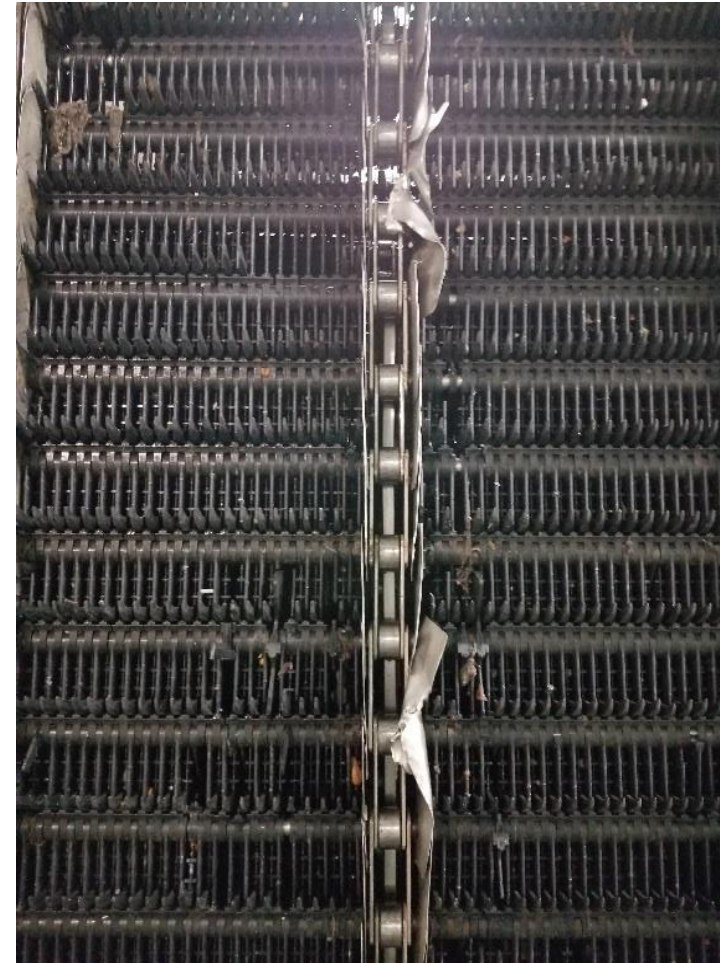
Grit Removal Barscreen is missing multiple teeth allowing trash to clog pumps throughout the treatment process.

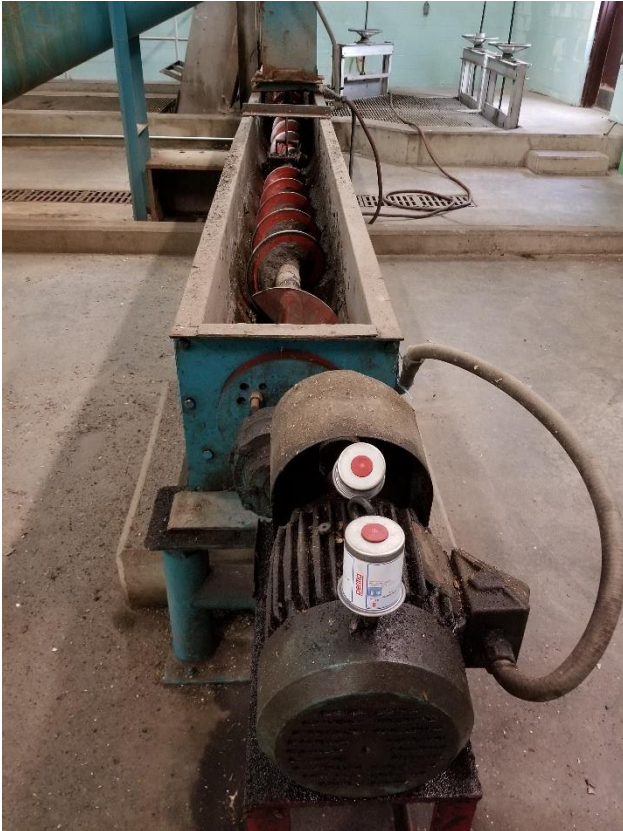
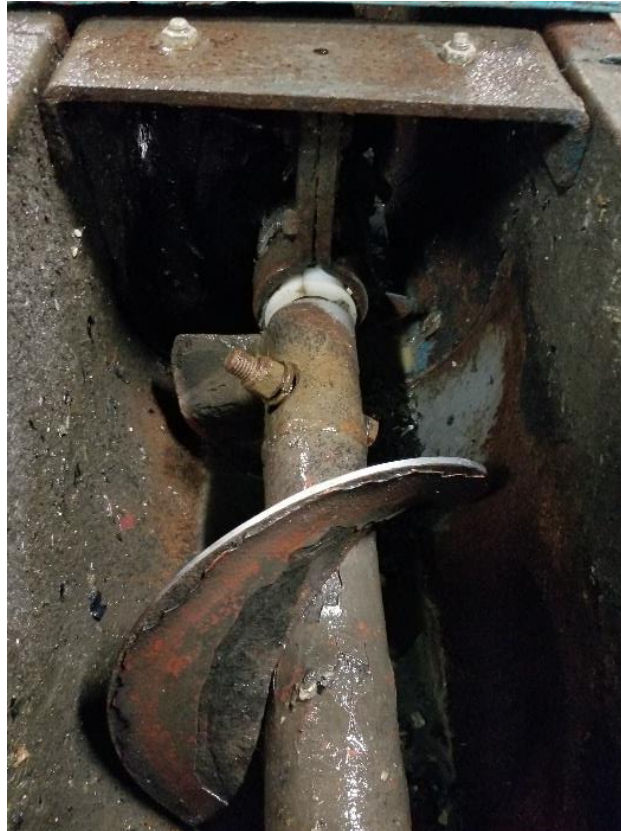
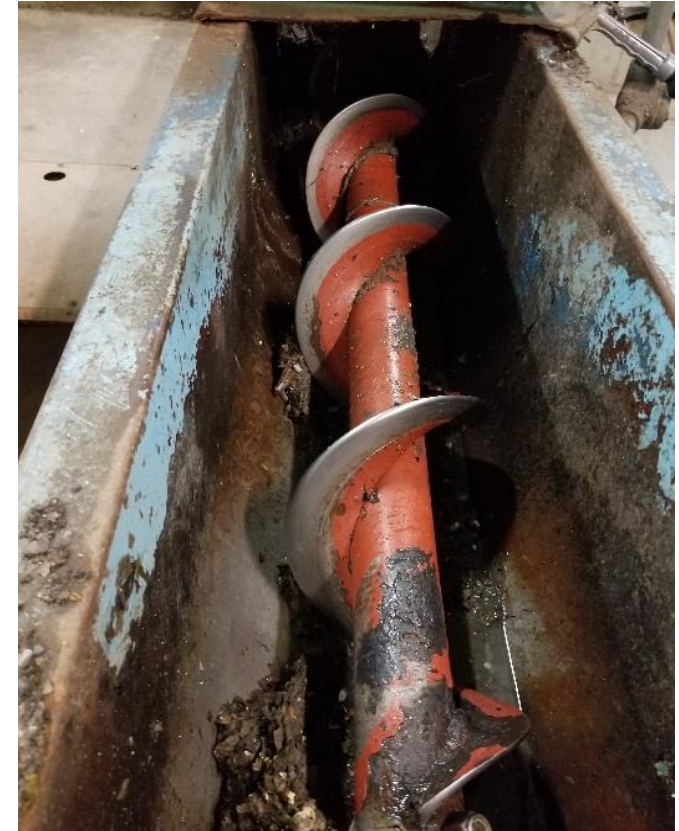
Grit Removal Screw Conveyor needs replaced due to wear and continuous amounts of repairs being performed.

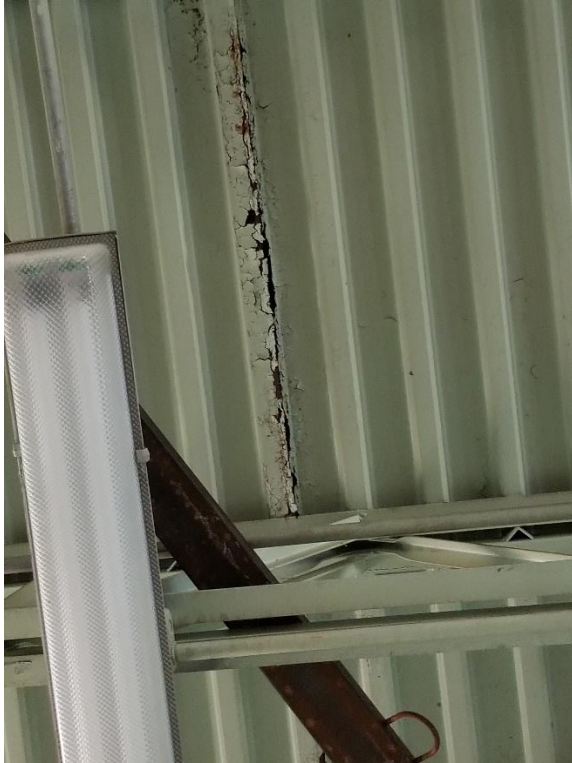
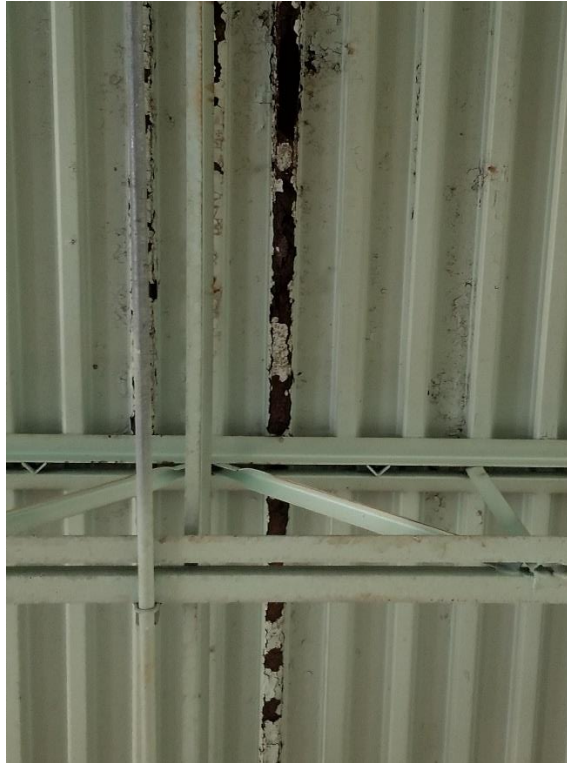
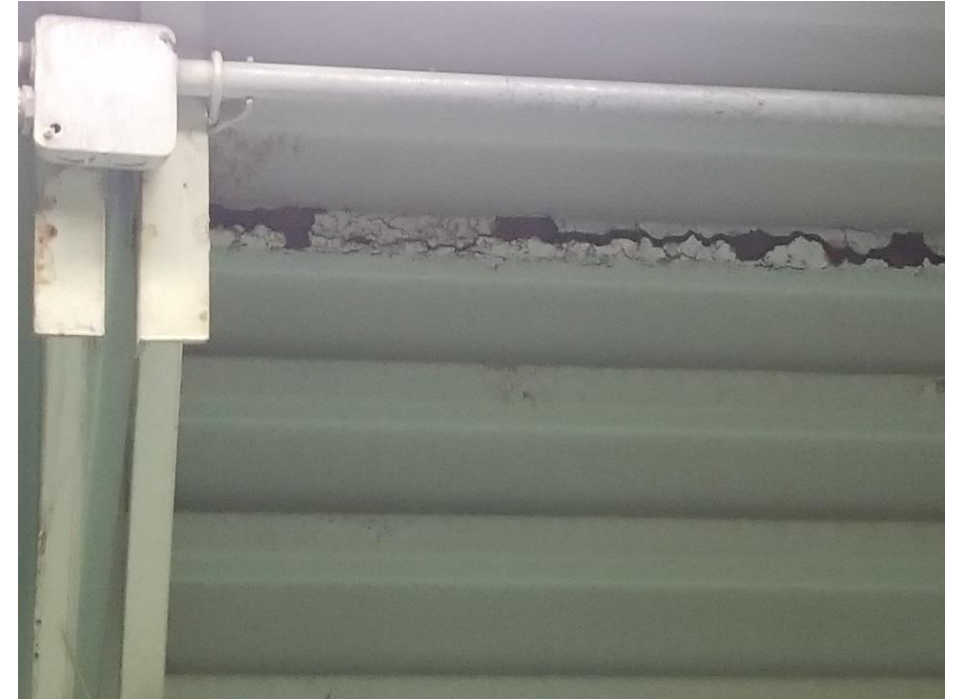
Roof is in need of repairs due to leaks in several different sections of the building.

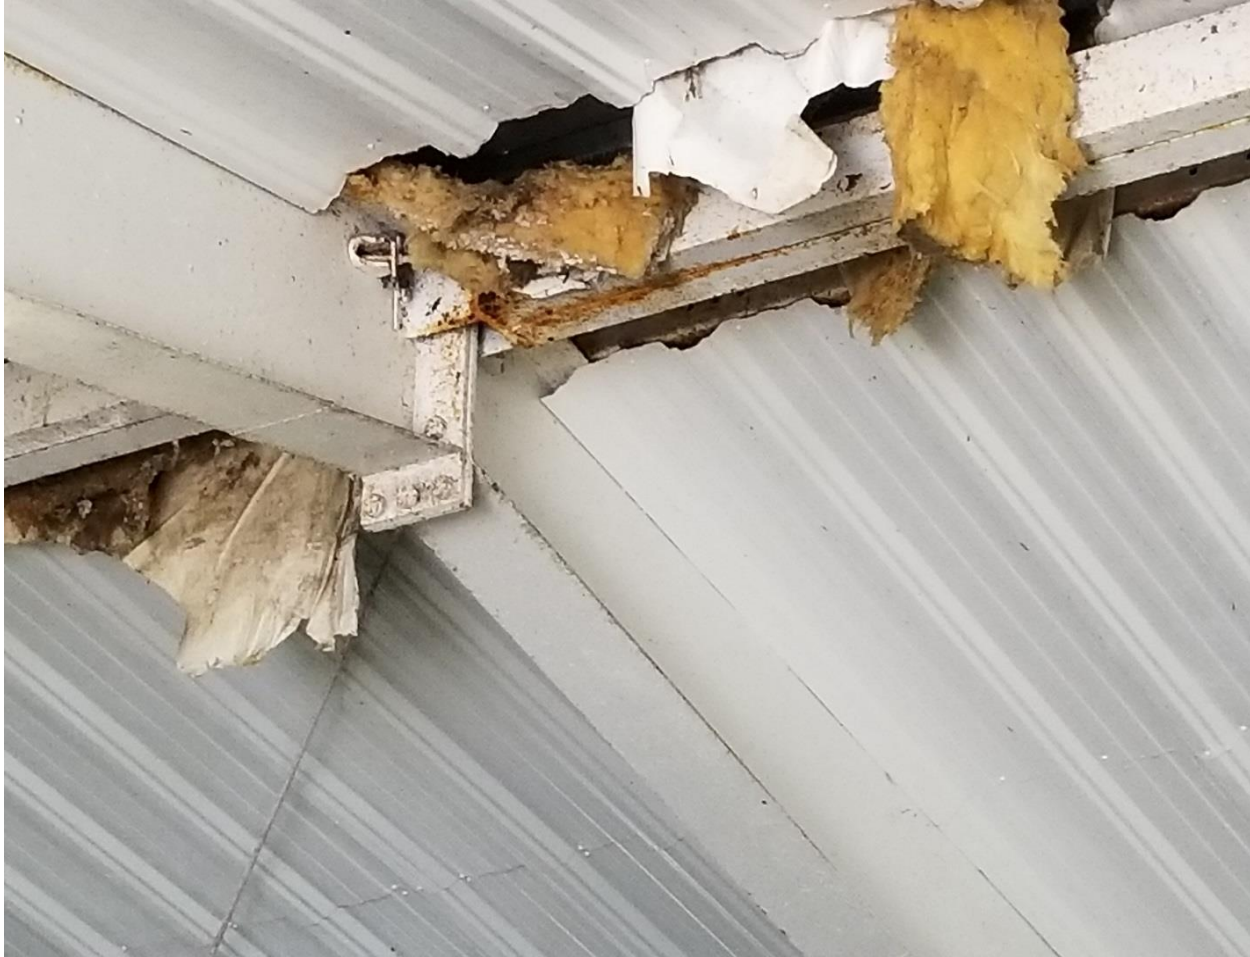
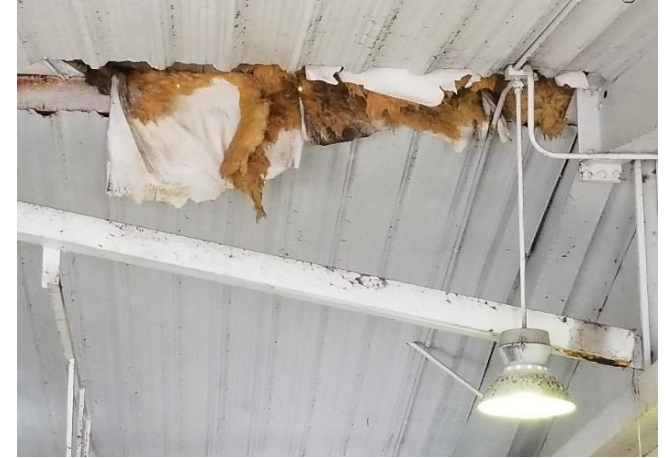
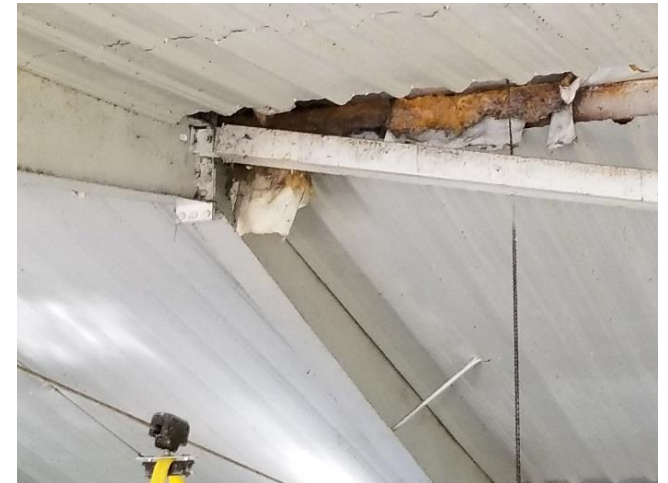
Roof is in need of replacement due to leaks in several different sections of the building.

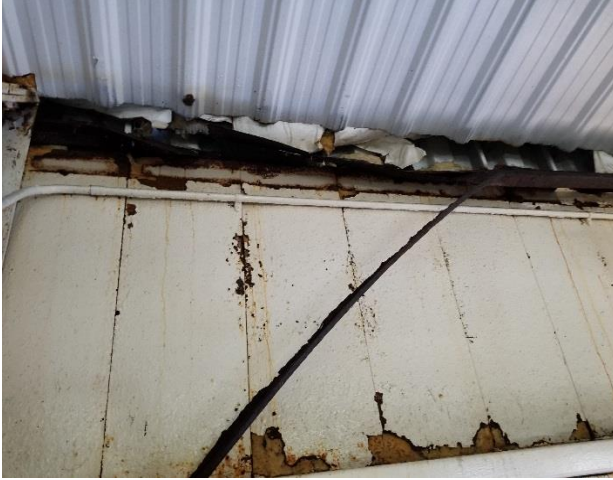
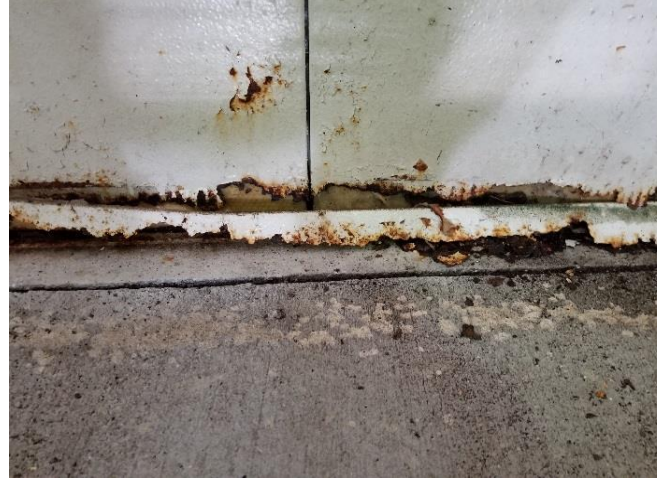
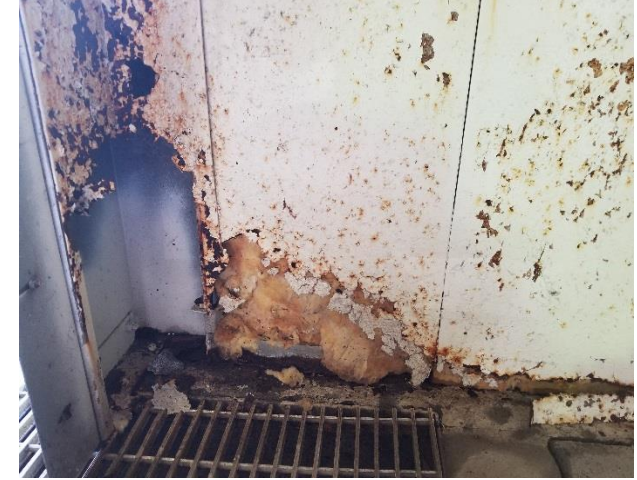
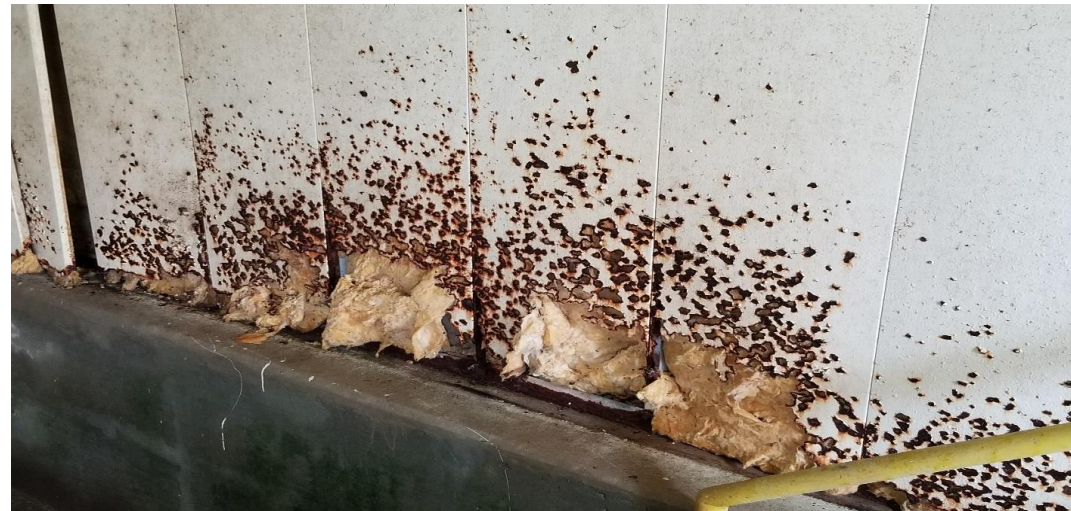
Metal Walls of the building need replaced due to rust and corrosion deterioration.

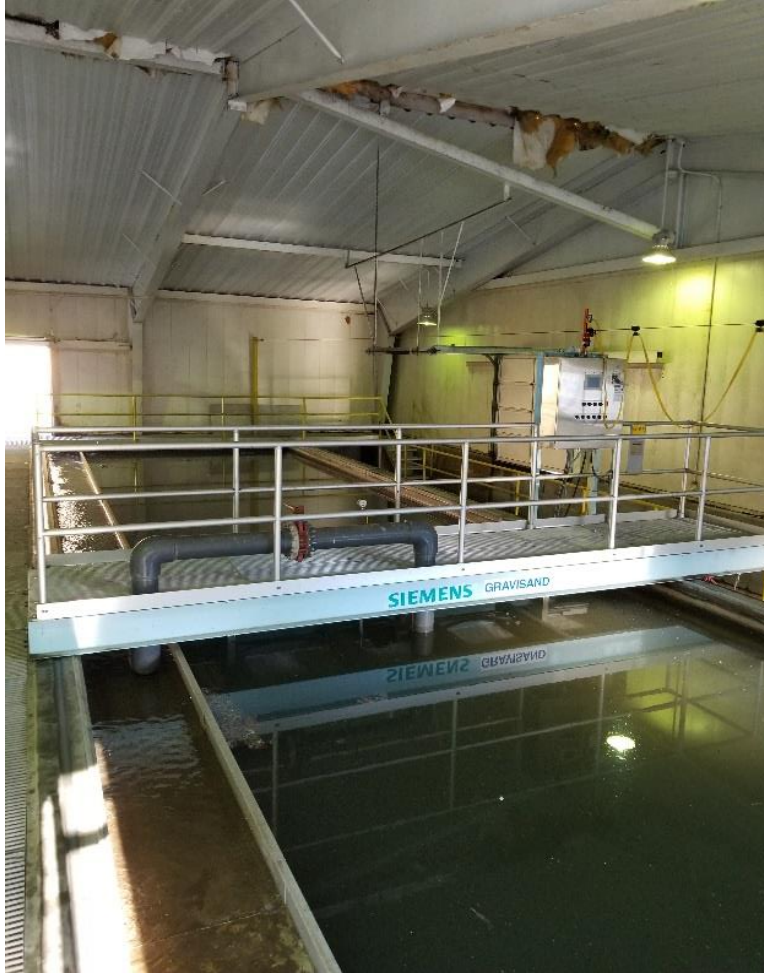
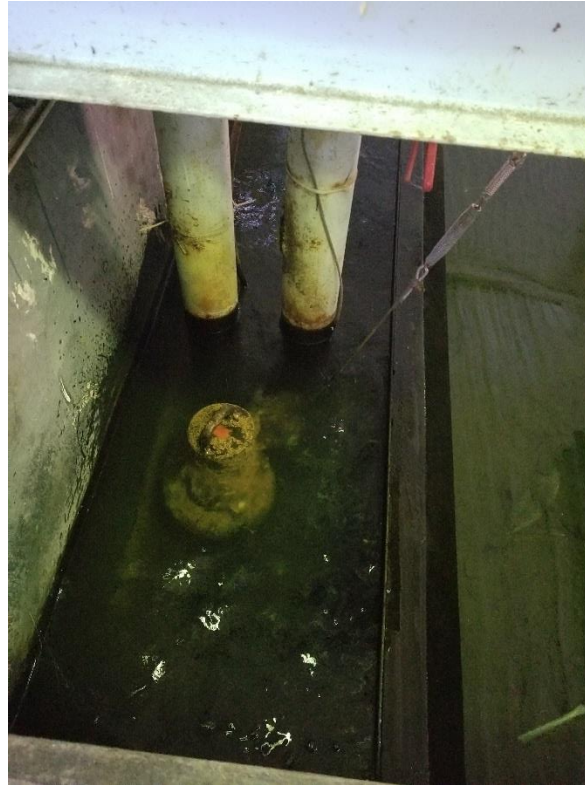
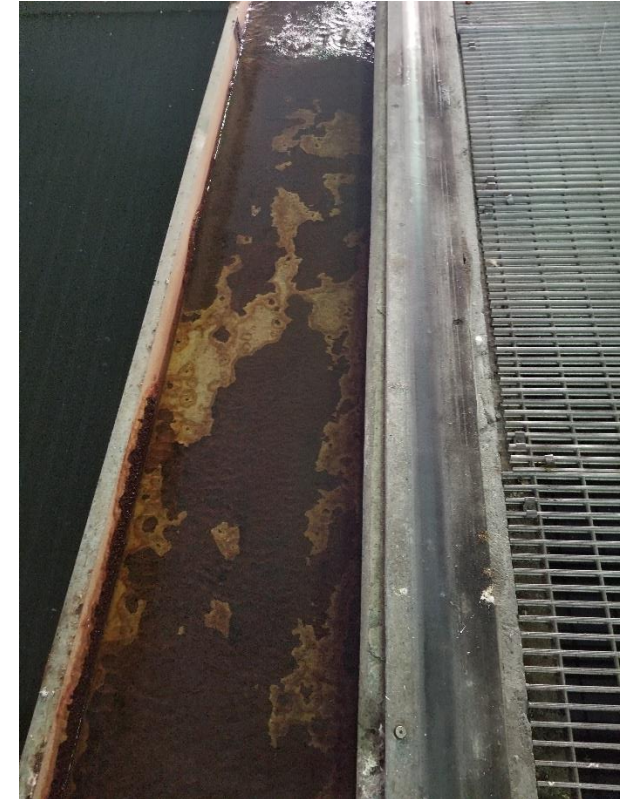
Sand Filter Traveling Bridges are antiquated technology that requires a heavy amount of annual maintenance. Needs replaced with low maint. Disc Filters.

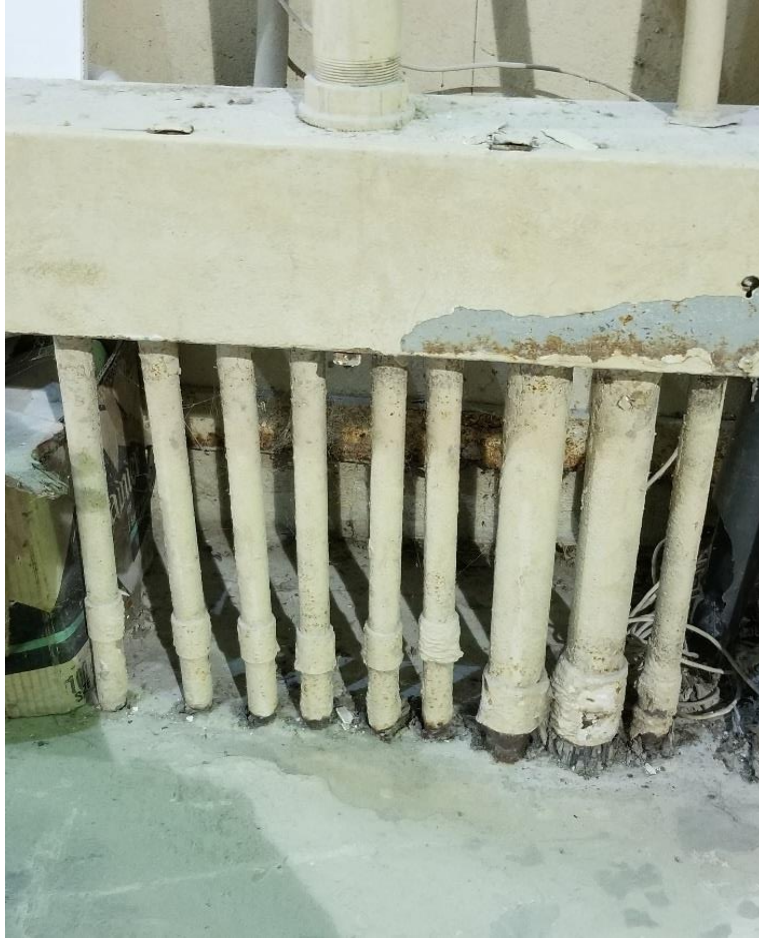
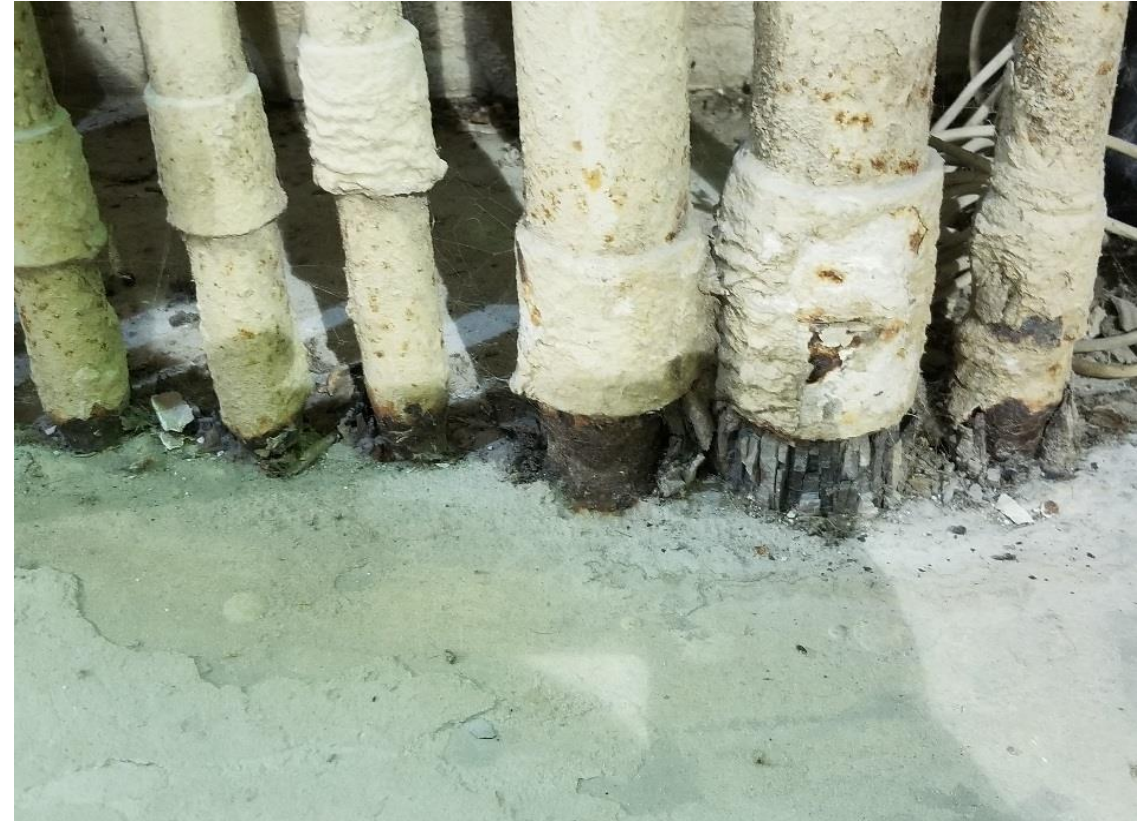
Major Electrical Work needs to be done throughout the main building. Conduit is rusted through, exposing live wire.
