## **Capital Improvement Project – Westside Plant, College Ave., Deerfield Pumpstation**

## ***Capital Improvement Project – Westside Plant – Headworks Building***

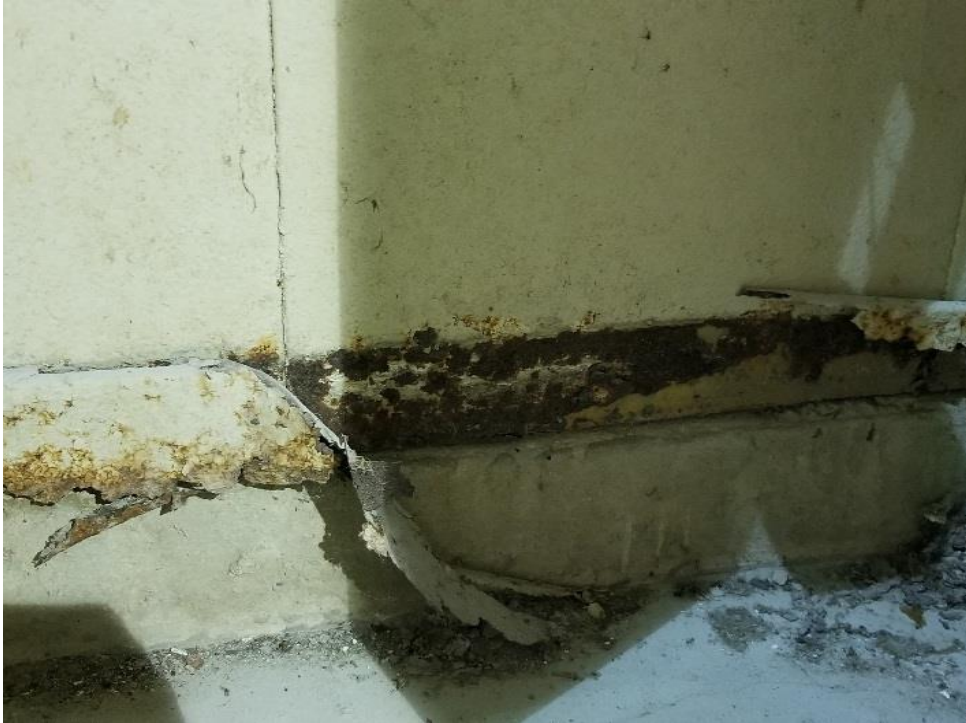
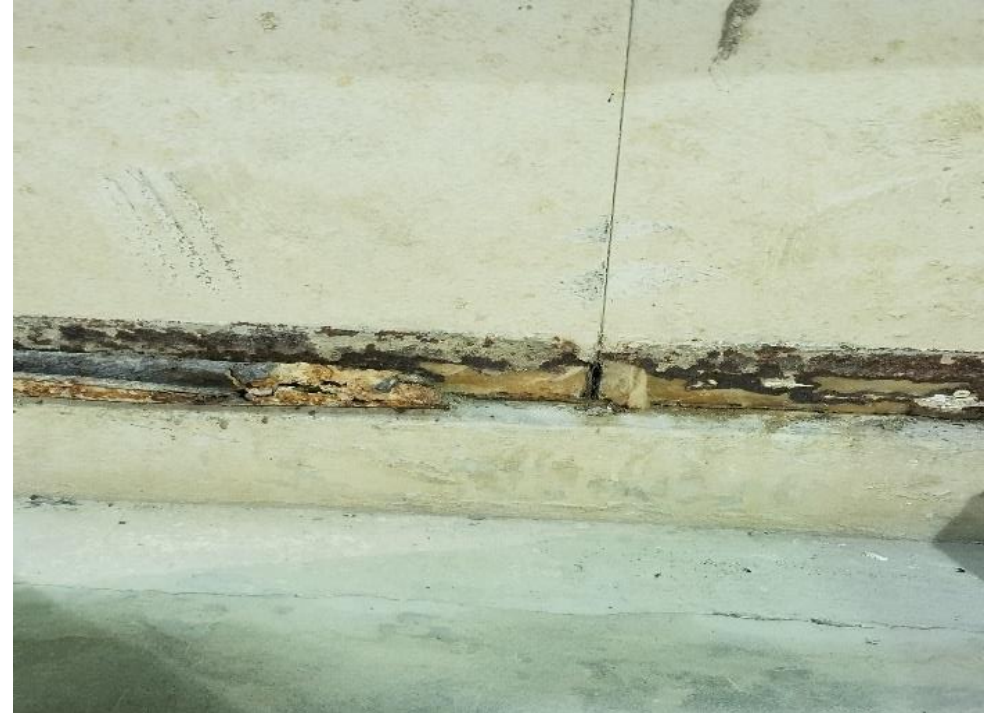
The walls inside of the Main Operations Building need repair due to rust and corrosion.

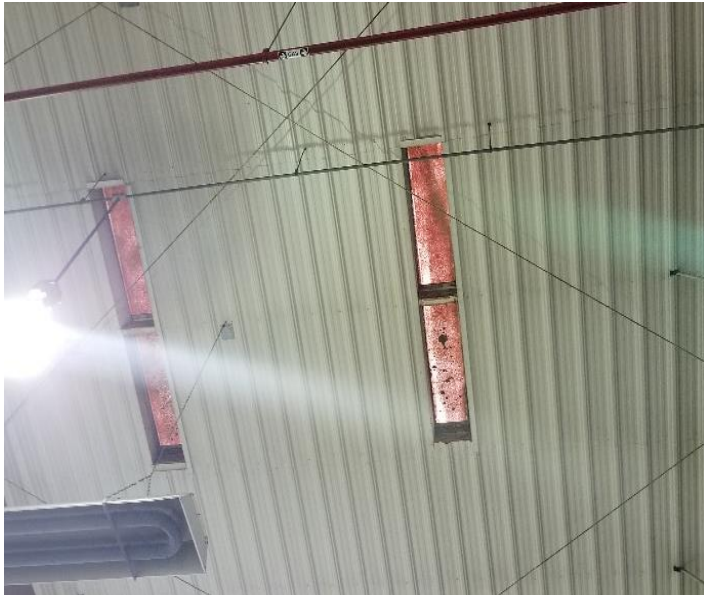
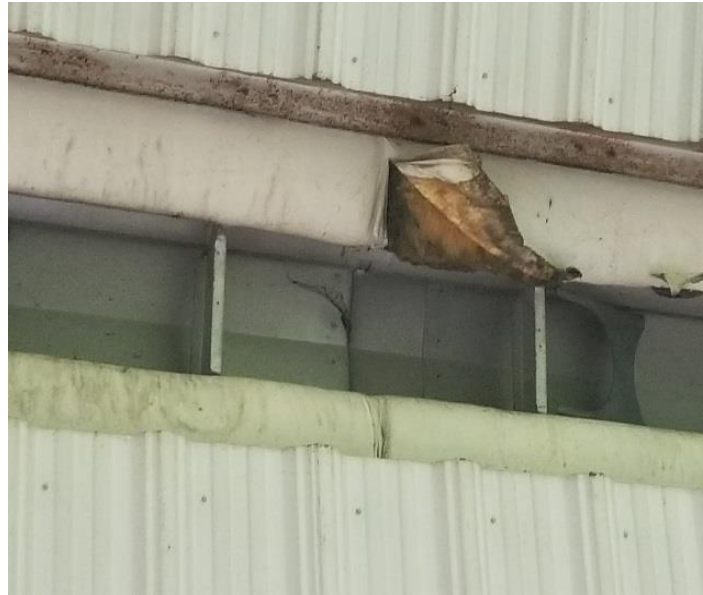
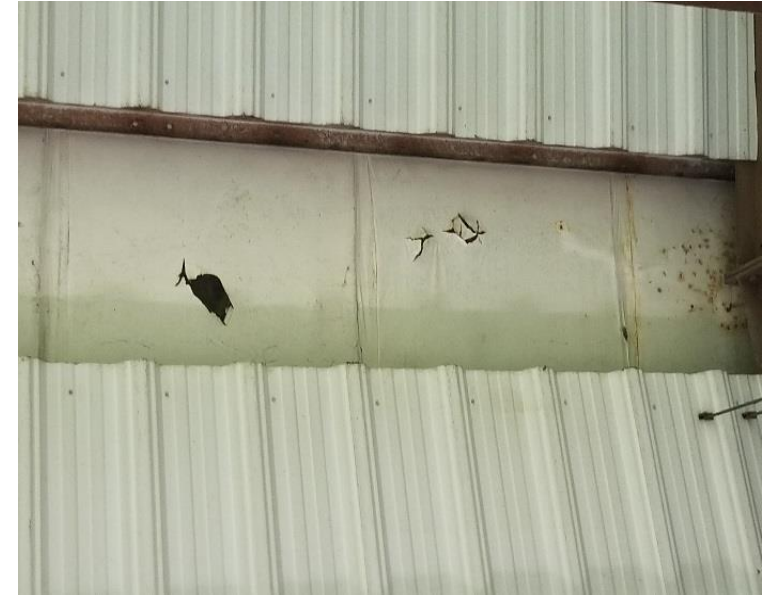
All skylights currently leak and need to be removed. Various locations on the roof leak and need to be repaired as well.

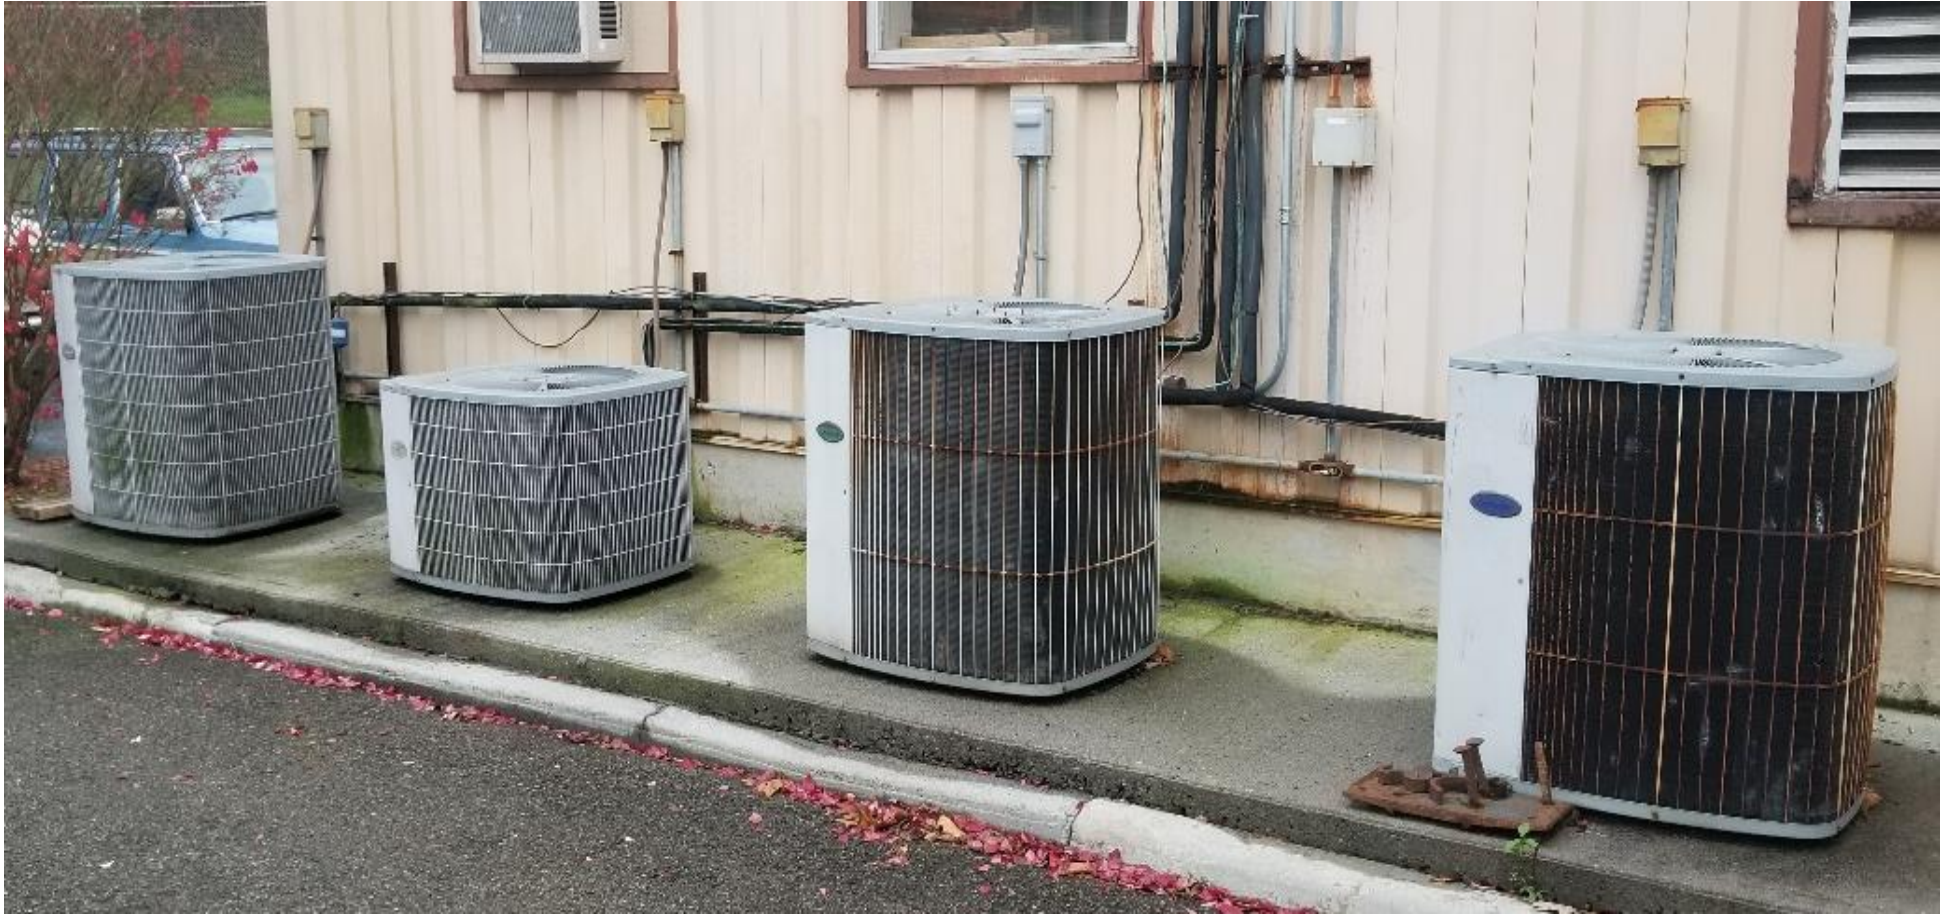
Three of the Four Heat Pumps do not work. All need to be replaced with energy efficient, natural gas models.

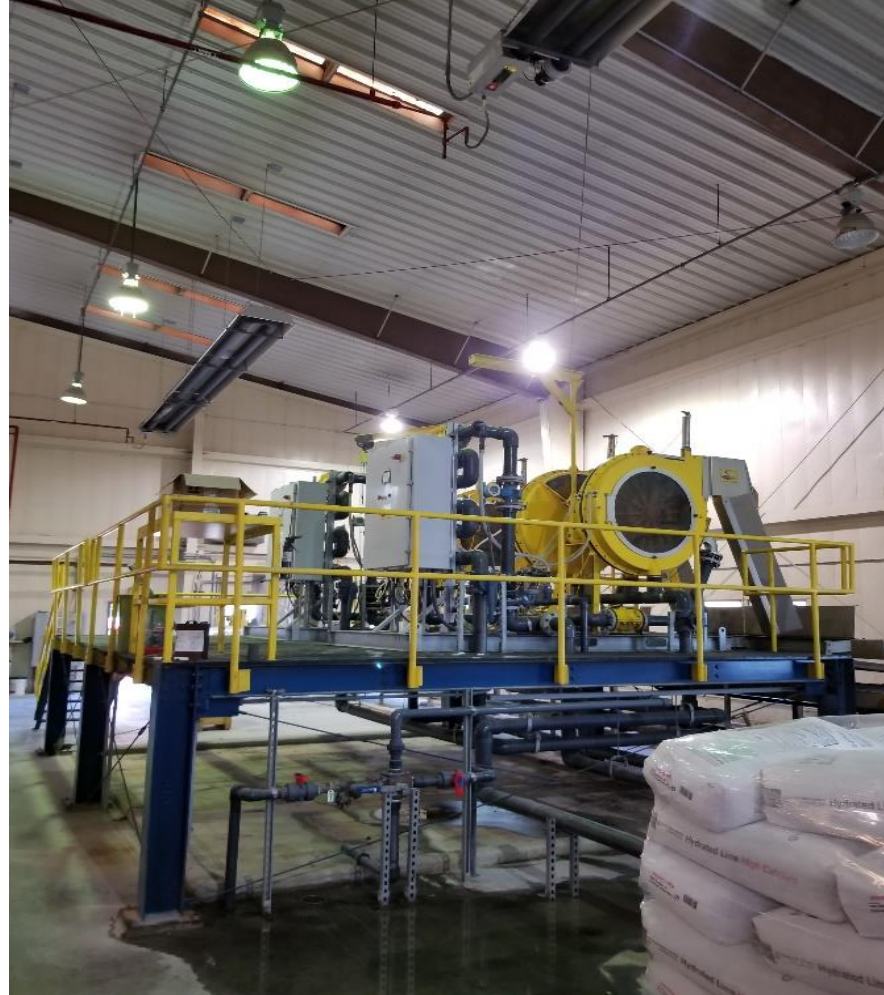
Three additional sludge processing fan presses need to be added to allow for efficient sludge removal from the plant by reducing processing hours/day.

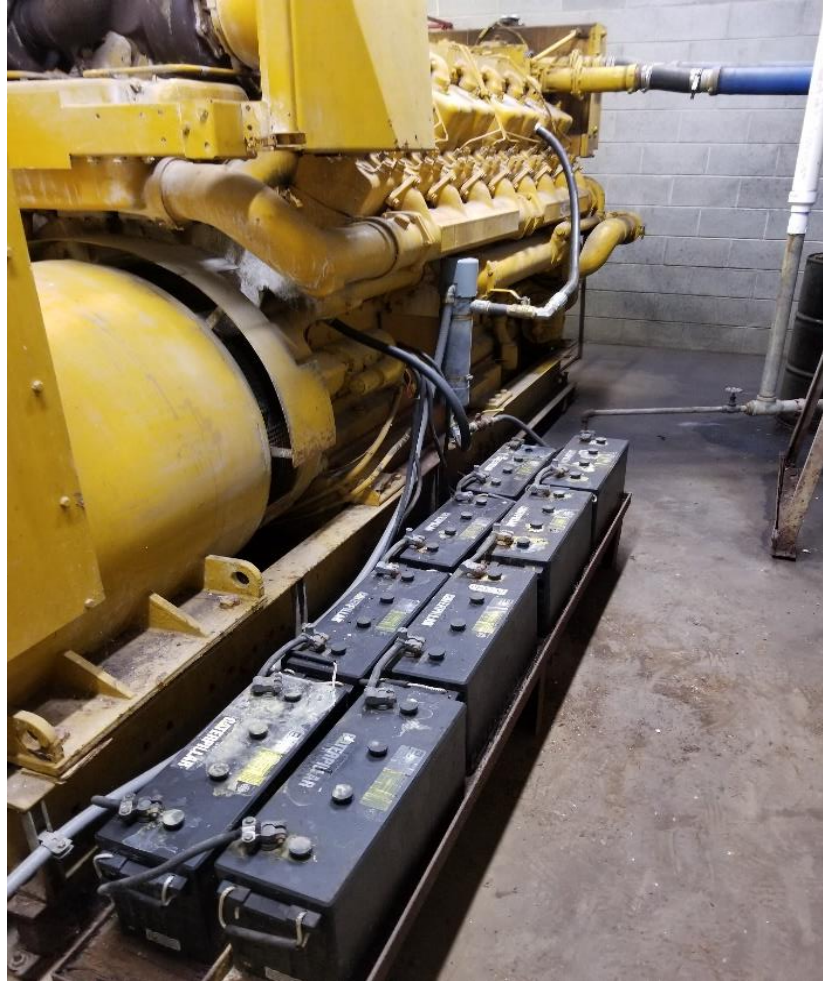
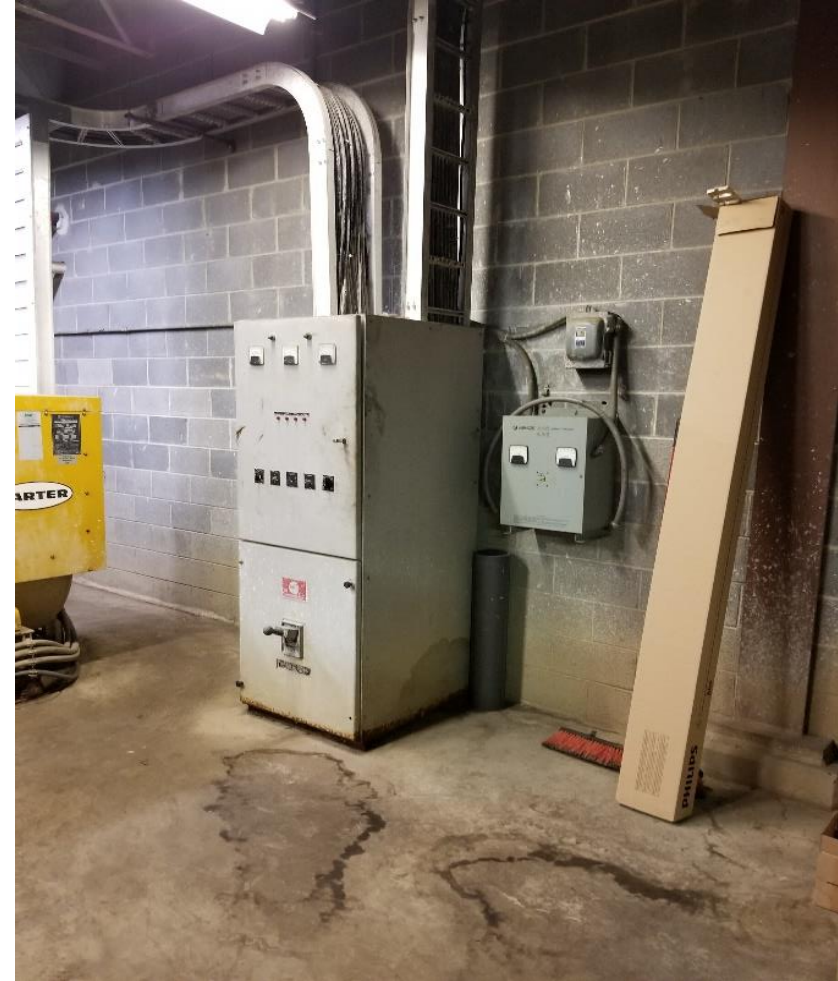
Main Operations Emergency Generator needs replaced. This 1975 model parts are obsolete

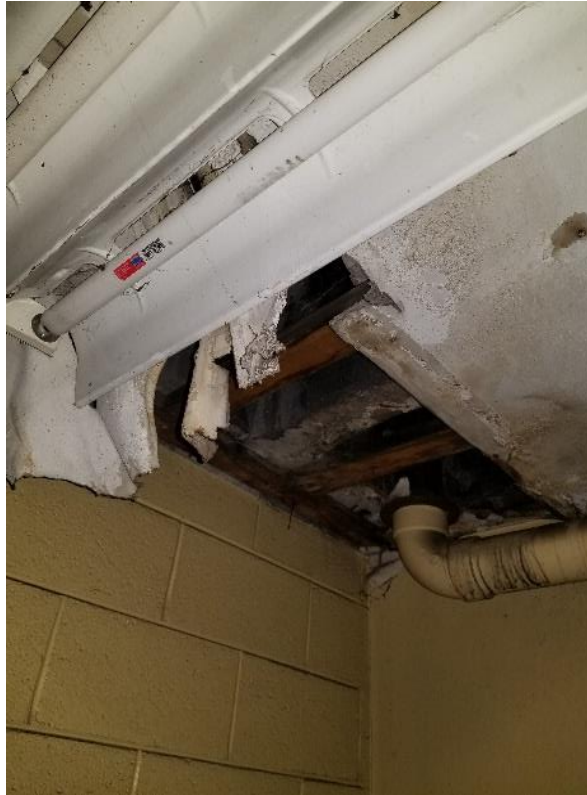
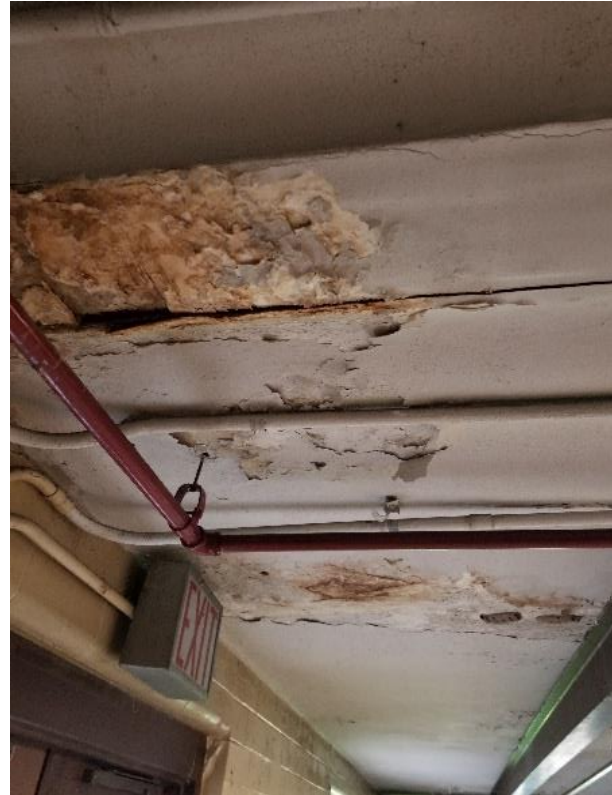
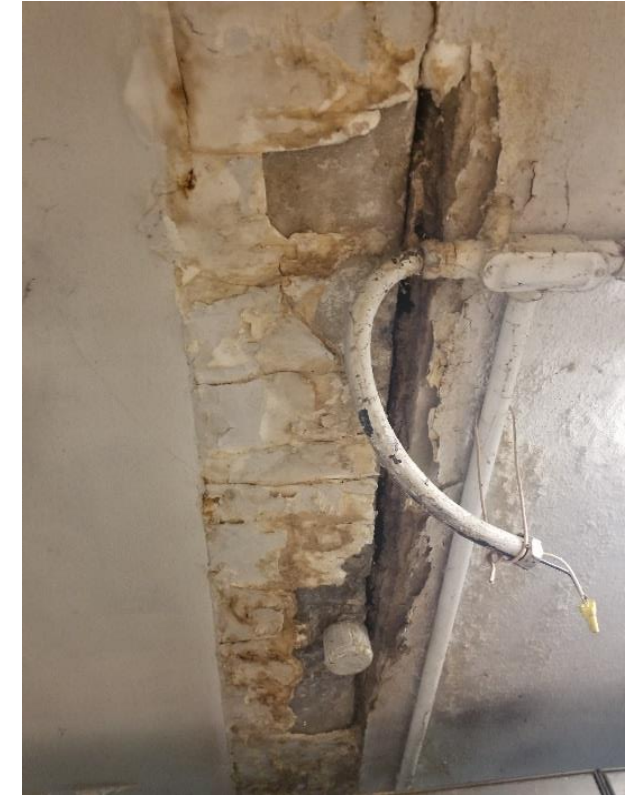
Roof and Inside Ceiling need to be replaced. Built in 1936 and never replaced.

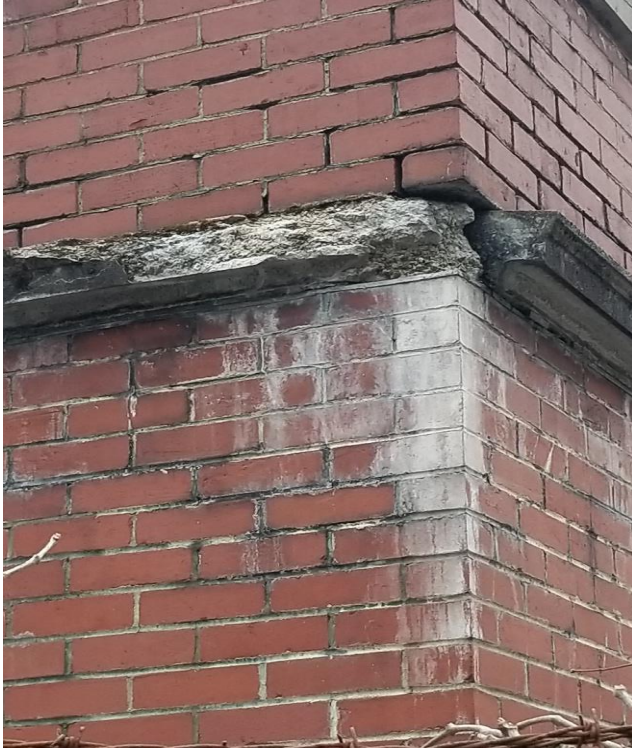
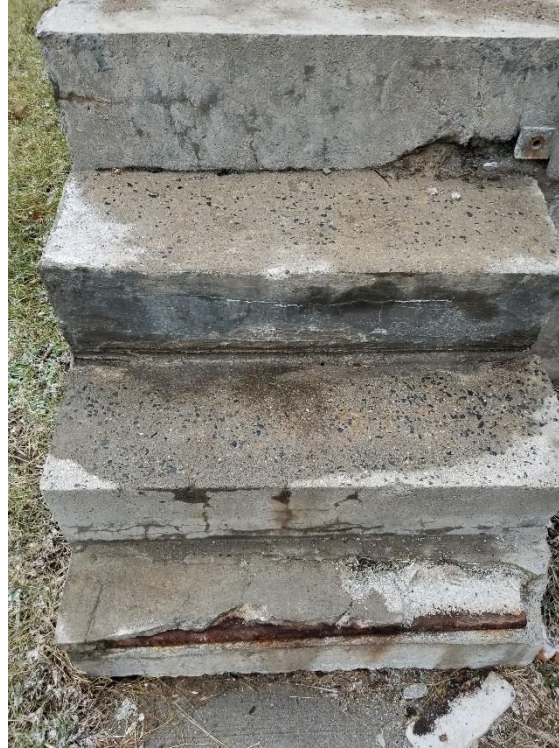
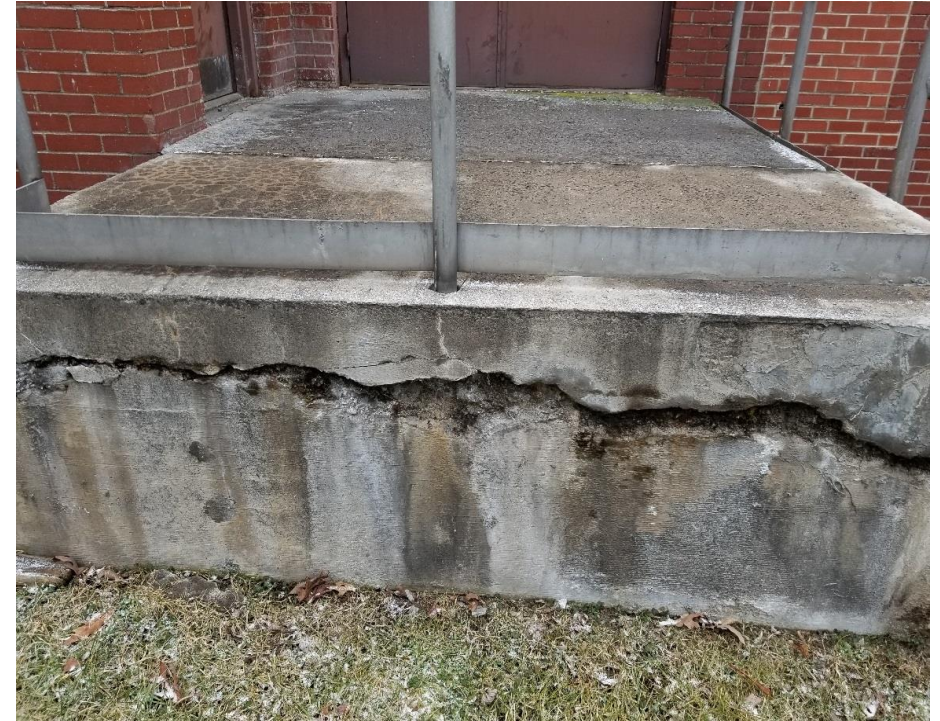
The main pump station building needs replaced due to decay.

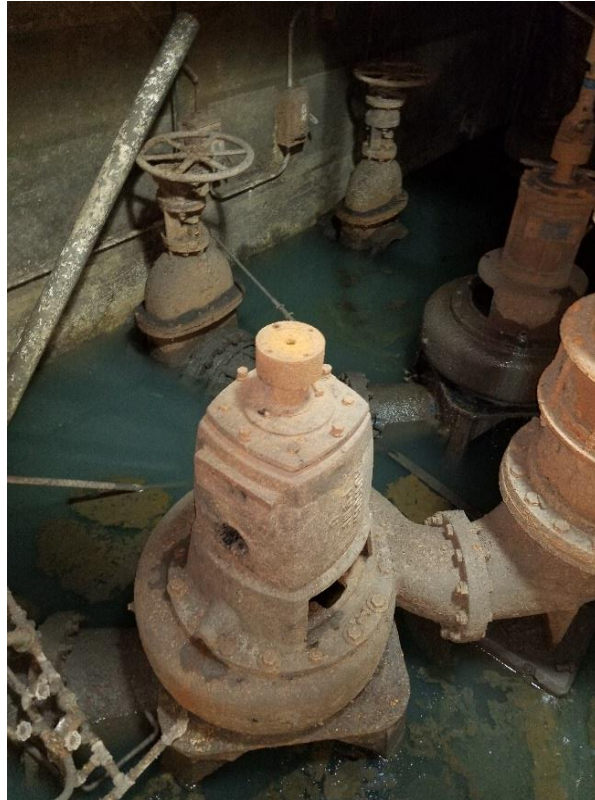
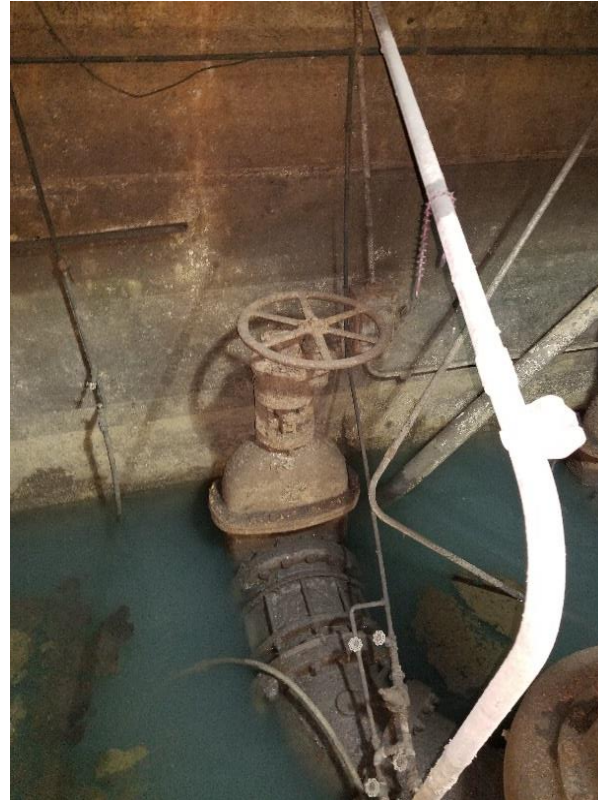
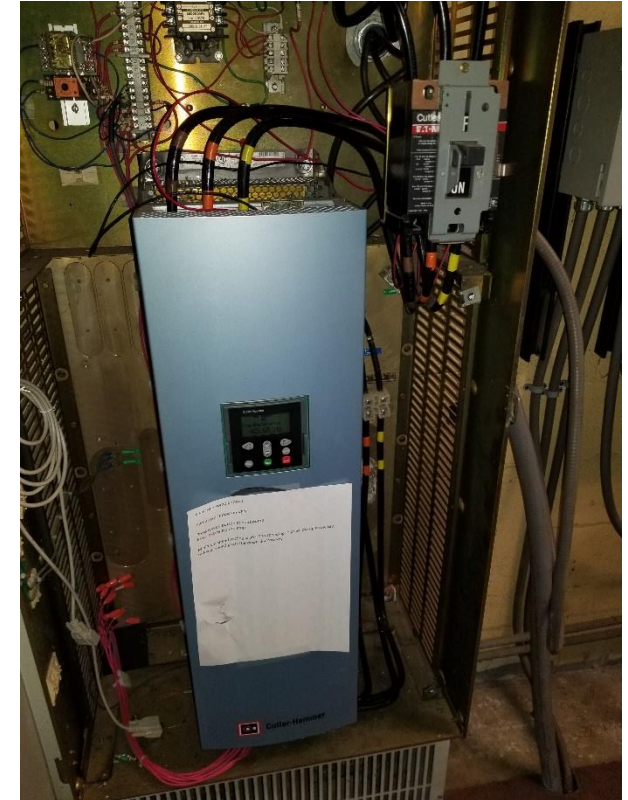
Pumps, valves, drive, and wiring need updated to keep up with extra flows when it rains.

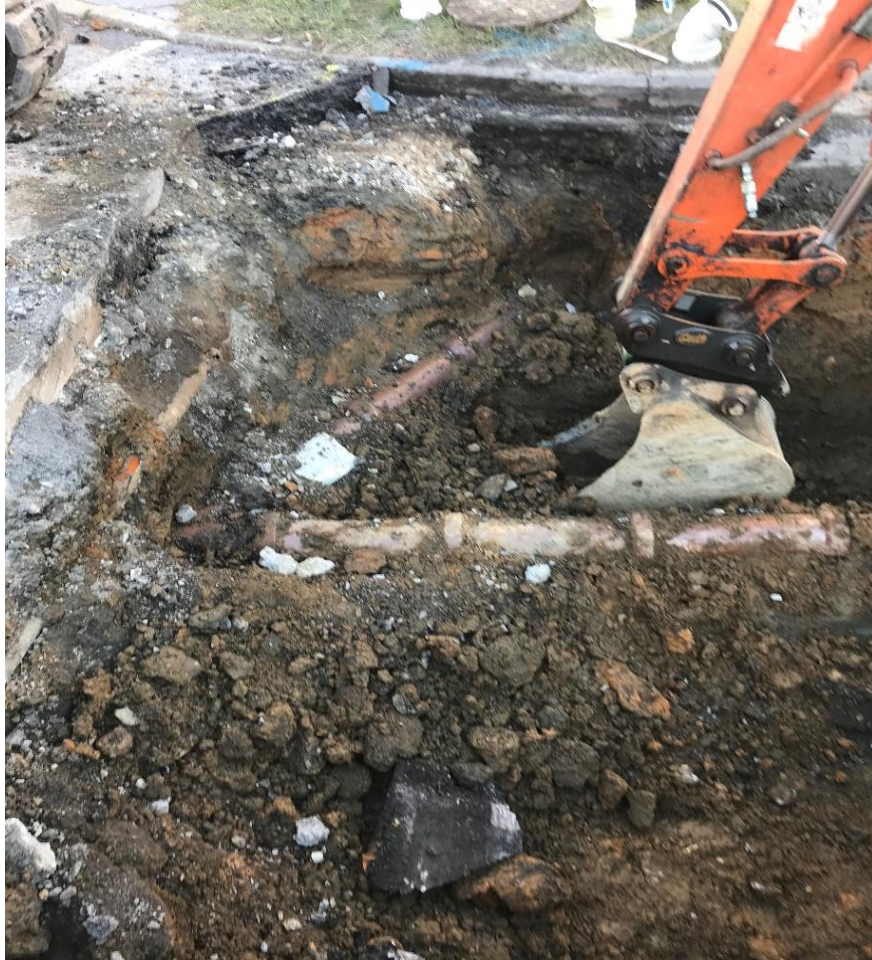
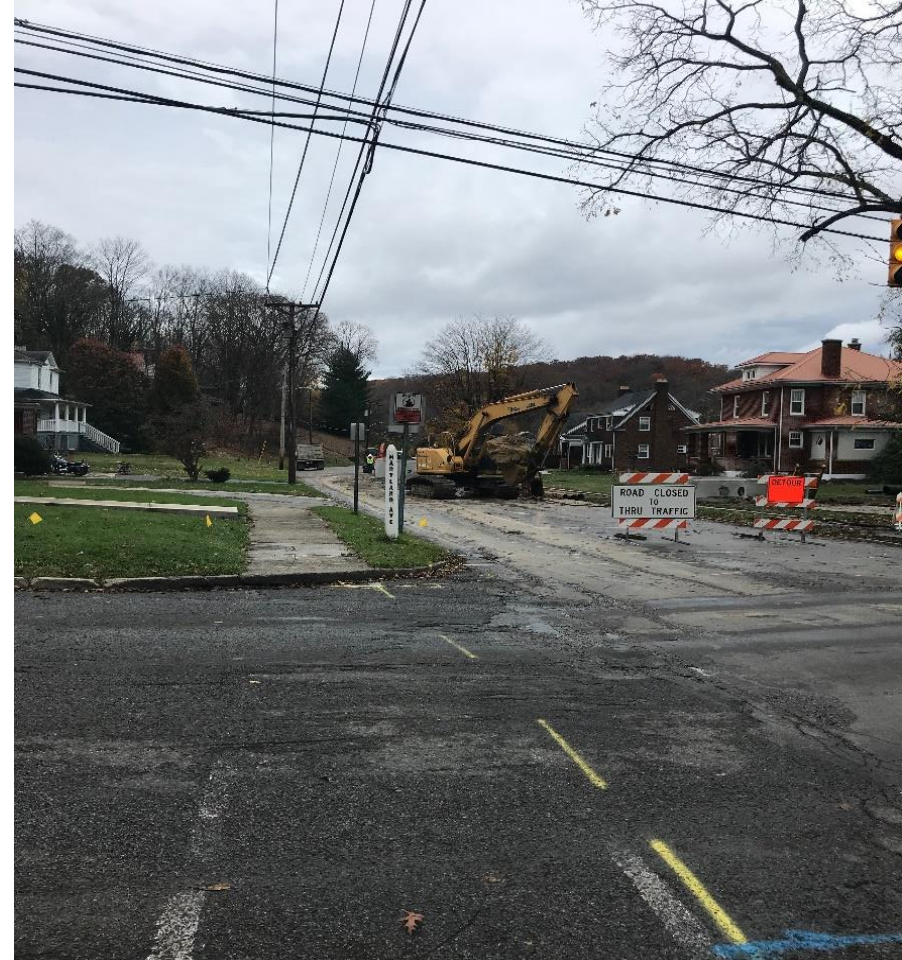
College Ave. Sewer Main was broken in multiple locations around Maryland Ave. and would overflow into the street during rain events.

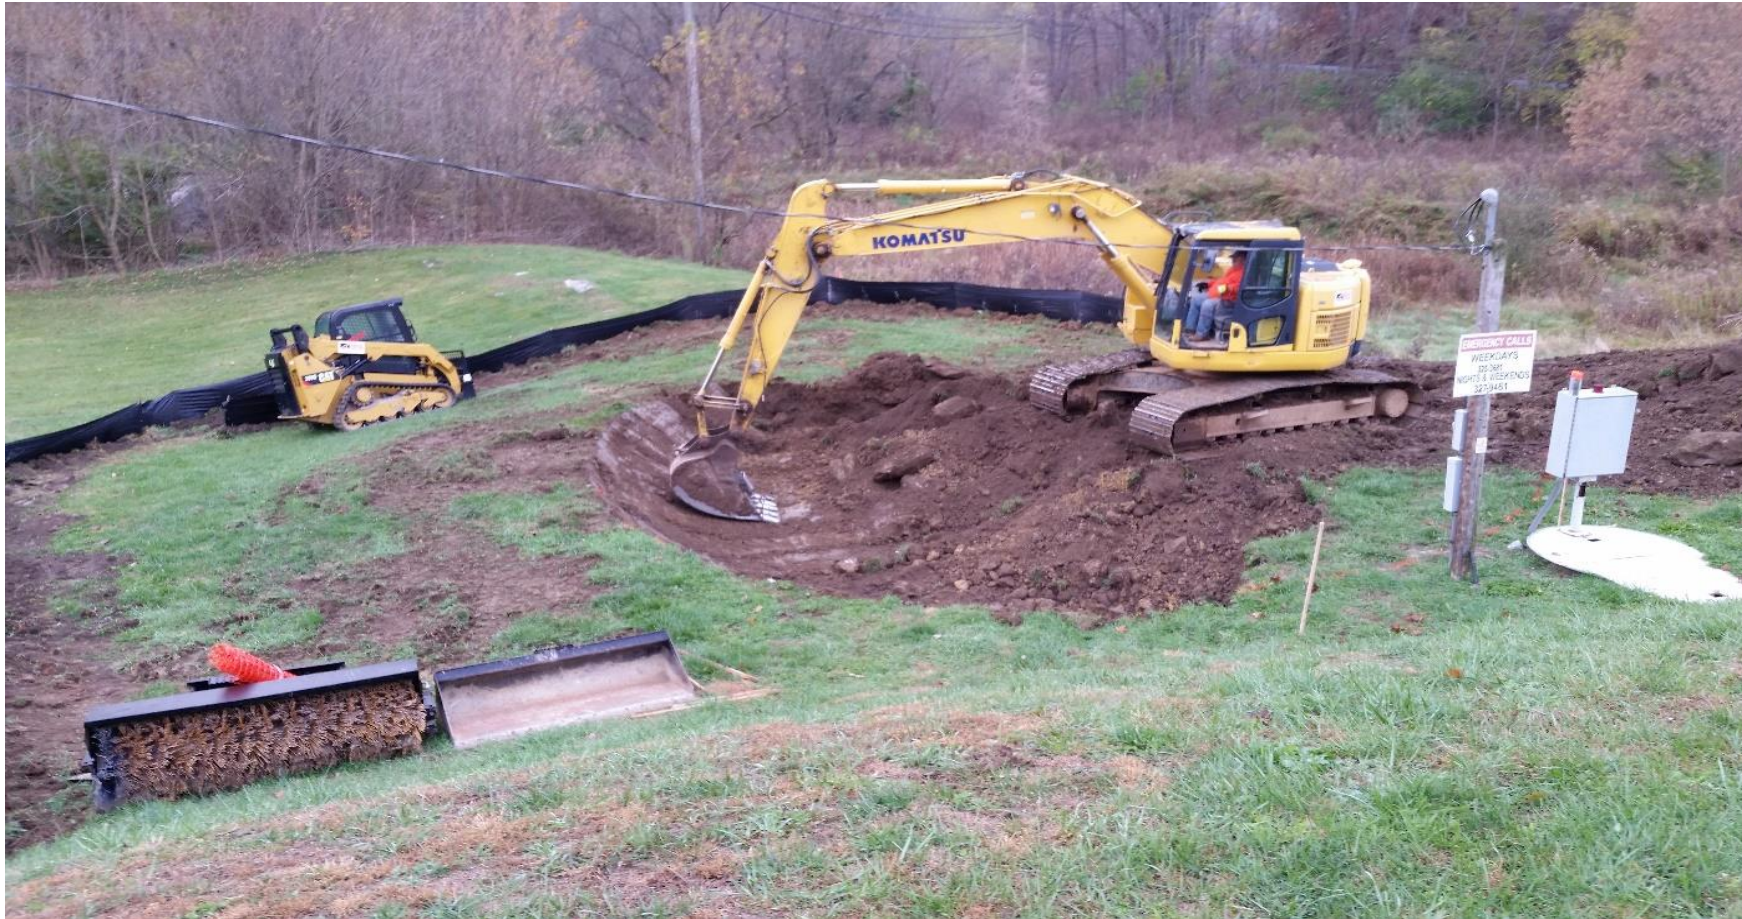
Deerfield Pumping Station was at its maximum capacity and no additional customers could be added and there was no backup generator when power fails.
